PORT HURON STUDY
Historical Development of Hydrocarbons
and Subsequent Problems

Walter Danyluk,
Michigan Department of Natural Resources
Geological Survey Division

1990

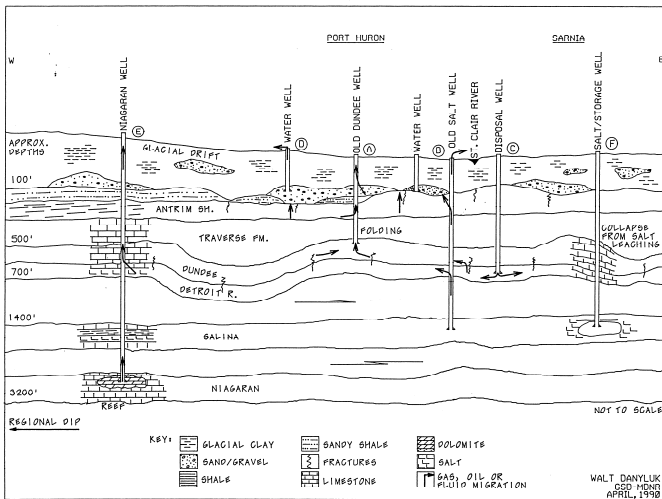
FIGURE 1. GENERALIZED SCHEMATIC OF SUBSURFACE IN PORT HURON

wellbore in the Dundee, Antrim, or Glacial Drift and migrate to upper zones, or to the surface. The same can occur in old salt wells (B), except here even more formations are involved. A good portion of the Case Histories represent this scenario.

Industrial wastes injected down a disposal well (C) can migrate, or thru increased pressure force formation fluids to migrate laterally in the Detroit River formation and enter old salt wells (B), or migrate into the Dundee formation thru fractures and eventually enter old Dundee wells (A). Actual access to the well-bore is the same as described for old Dundee wells.

Deeper, more recent Niagaran wells (E) provide other potential avenues for gas/fluid migration into higher rock formations, or to the surface. Again, entry into the wellbore occurs in portions of the hole that may not be cased, cased but corroded, or improperly plugged. Case History 44 is an example.

In all the cases above, migration can also occur via the annulus (space between wellbore and the casing) if it is not properly sealed.

FIGURE 1: DESCRIPTION

The schematic of the subsurface in Port Huron is a composite of the Case Histories depicting the various ways by which hydro- carbons and fluids (brines, brackish and fresh water) can migrate between different formations, and between formations and the surface.

The old Dundee well (A) shows that if the well is not (properly) plugged, or not cased at all, or cased but corroded/damaged, fluids and gas can enter the

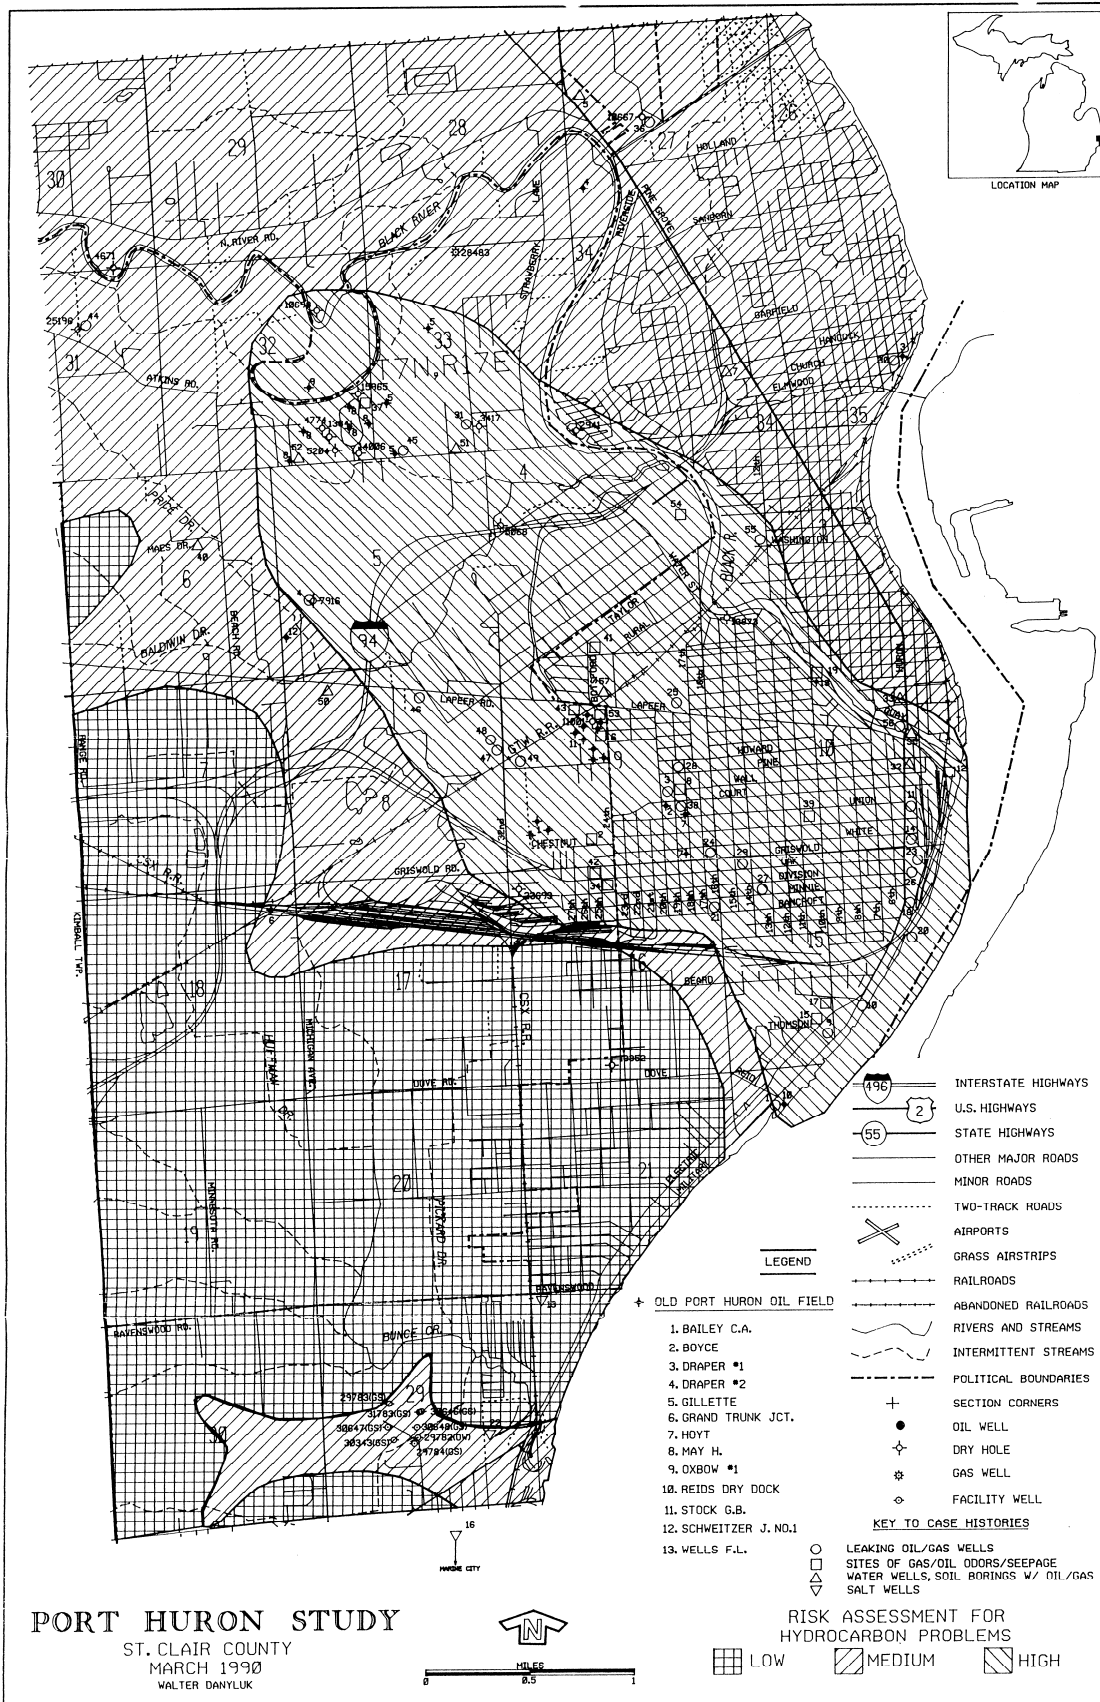
[MAP 1: Risk Assessment for Hydrocarbon Problems]

This risk potential map addresses the probability of hydrocarbon releases from naturally occurring sources, either direct from the subsurface, or through improperly sealed wells and borings. The map is an interpretation based on geologic information, all known wells that were drilled, reported (and documented) problems related to hydrocarbon releases/leaks, and historical knowledge of industrial development. This delineation of risk potential is not an absolute determination that problems will or will not occur, but is meant to serve as a planning tool to guide land use decisions.

This area is basically defined as that which is underlain by the Antrim Shale subcrop. There is some potential for natural gas accumulation/leakage thru water wells, test borings, etc.. Gas can also migrate up into overlying glacial sediments and escape or vent to the surface thru natural avenues.

High Potential

Hydrocarbon releases can occur from natural gas accumulations from the Antrim Shale subcrop; gas, oil and brine leakage from old and improperly plugged Dundee (or deeper) wells; or from old salt/brine wells. The area is defined as that which overlies the Antrim Shale subcrop, a NE-SW trending structural high (anticline) in the Dundee formation with associated oil well deve-lopment, and historical/geographic distribution of industry and city development.
