# Brown Bridge Dam – Temporary Dewatering Structure

## Root Cause Analysis of the October 6, 2012, Failure Incident

June 2014

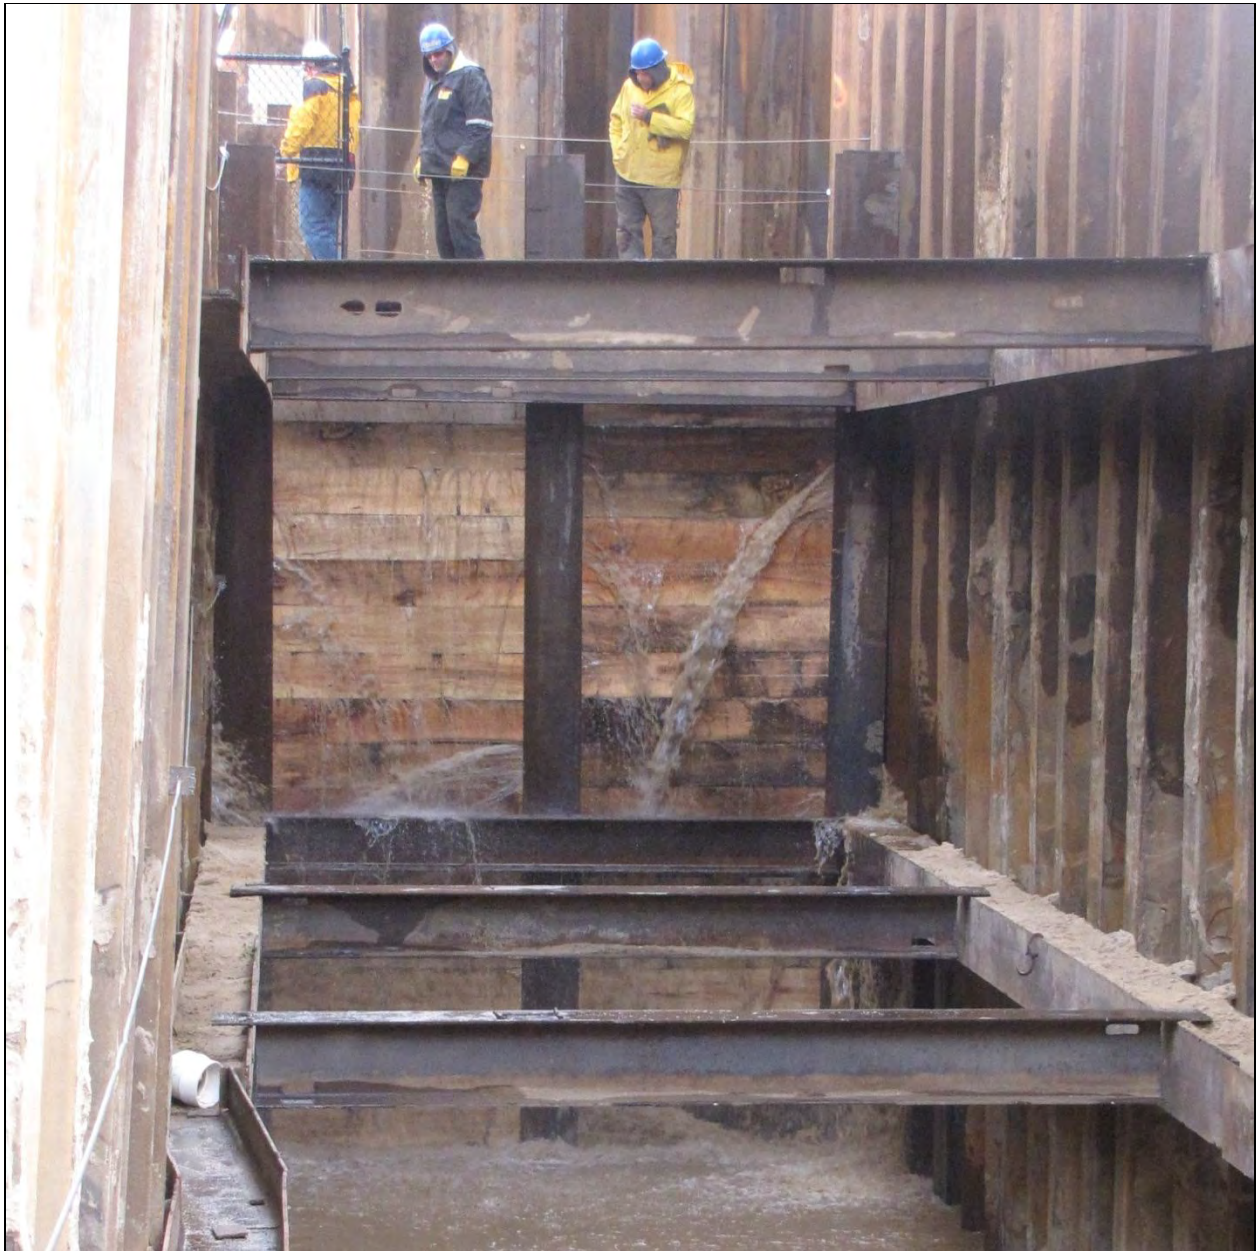
At approximately 10:00 AM on October 6, 2012, a single steel sheet was removed from the TDS headwall to allow water to flood the forebay for testing of the stoplog weir and concrete control section. As the water level in the forebay equalized with the impoundment level minimal flow over the stoplog weir, leakage between the timber stoplogs was observed, as shown in Figure II-4 below.

**Figure II-4.** Photo of TDS stoplog weir at first testing  
*Photo courtesy of AMEC*

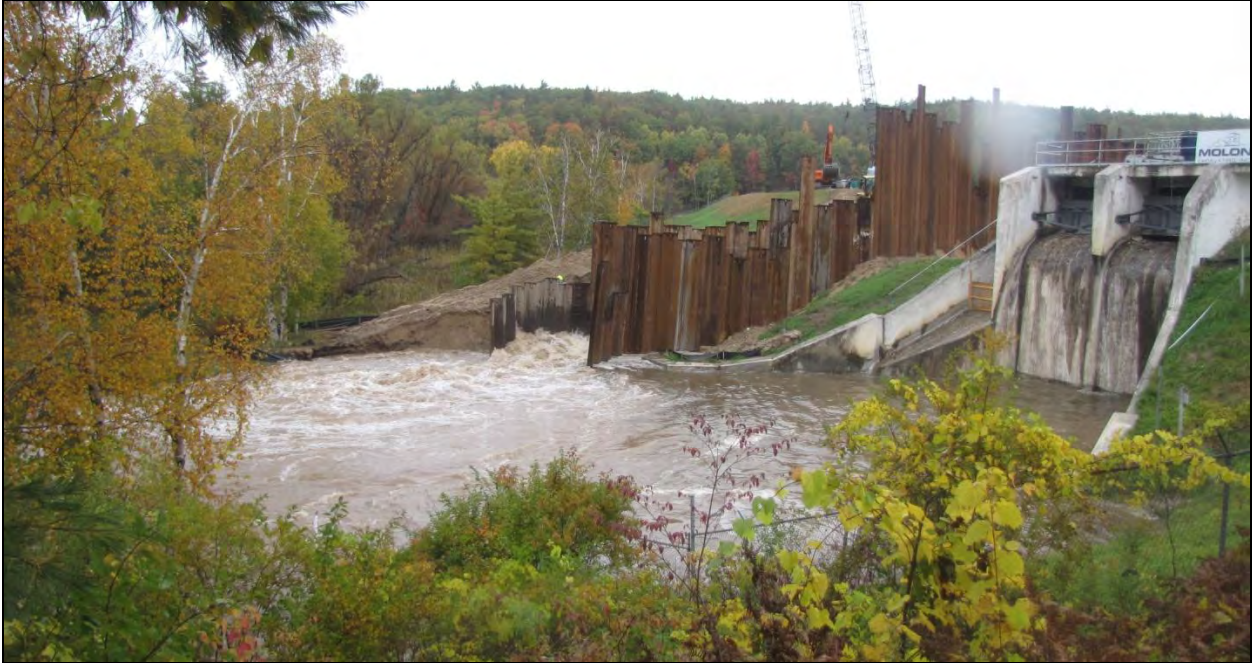
Flow from the boil increased rapidly, causing scouring of foundation soils from underneath the TDS control section, turbulent flow through the downstream TDS channel, and a rapid rise in the tailwater elevation below the TDS outlet, as shown in Figure II-6 below.

**Figure II-6.** Photo of TDS channel with turbulent flow from boil  
*Photo courtesy of AMEC*

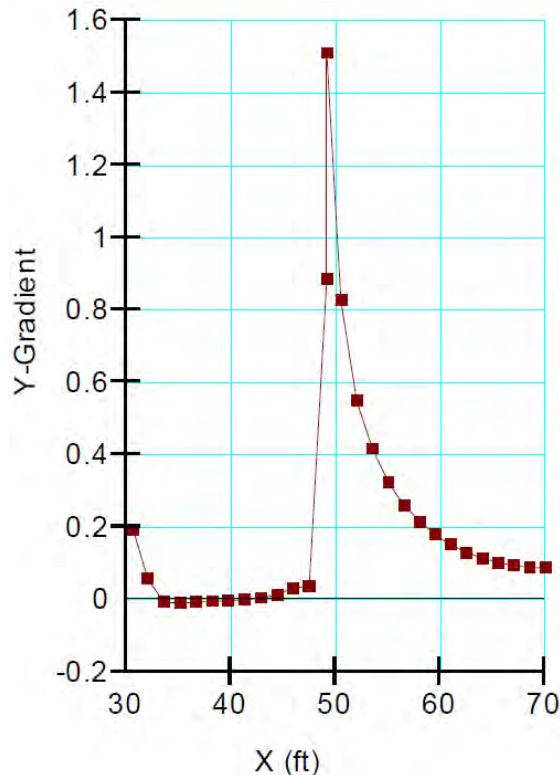
**Figure VI-1.** Plot of  $i_{exit}$  versus downstream distance

Based on the analysis,  $i_{exit}$  was estimated to be approximately 1.50 at the end of the concrete slab, as shown in Figure VI-1 below. It should be noted that hydraulic exit gradient is independent of hydraulic conductivity when the soil is homogenous and isotropic.

Critical hydraulic gradient occurs when the hydraulic exit gradient approaches a value of 1.0, much less than the value of 1.5 predicted by the model. This indicates that the hydraulic loading of the TDS foundation soils very likely resulted in a “quick” condition as described above. Additionally, a factor of safety (FS) against piping for the TDS soil foundation can be computed using the following equation:

The FS calculated from the above estimated critical and exit gradients for the TDS foundation is 0.67. Generally, an FS of 3 to 4 is required for the safe performance of a structure; thus indicating an inadequate FS for the TDS structure to perform safely.

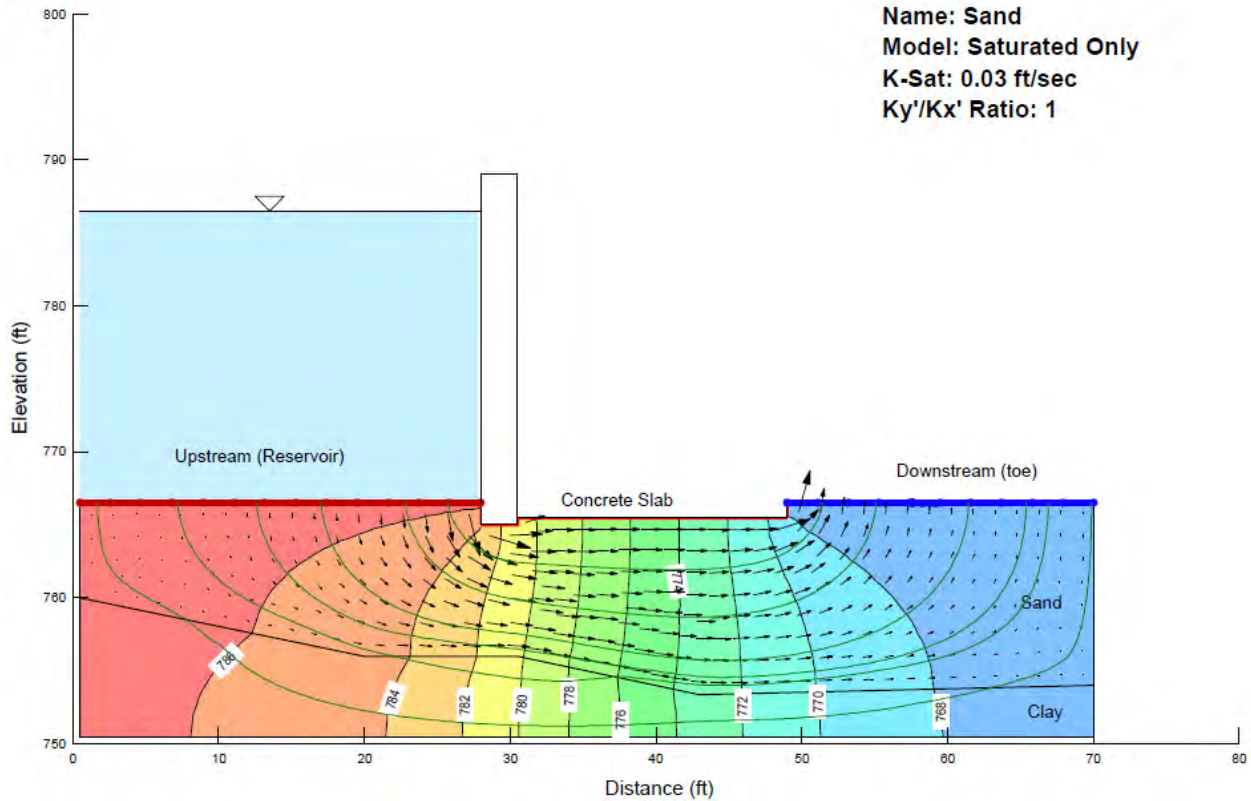
**Figure VI-2.** SEEP/W flow net for  $k = 0.03$  ft/sec

Also shown below in Figure VI-2, is a flow net developed by the SEEP/W model showing the potential flow paths for seepage under the structure. The  $k = 0.03$  ft/sec condition is shown in Figure VI-2. It should be noted that the model predicts high seepage velocities at the terminal end of the concrete slab in both cases. This is consistent with the location of the initial boil that developed during the TDS failure.
