Zimba Main Farmstead Production Area Map

Zimba Farm 2
Production Area

North Branch White Creek Fish Community and Fishery Damage Assessment

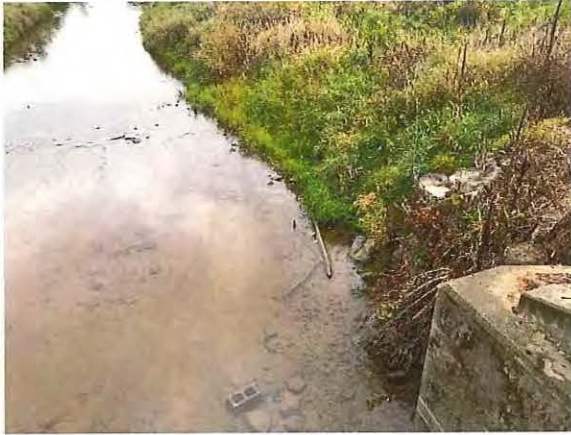
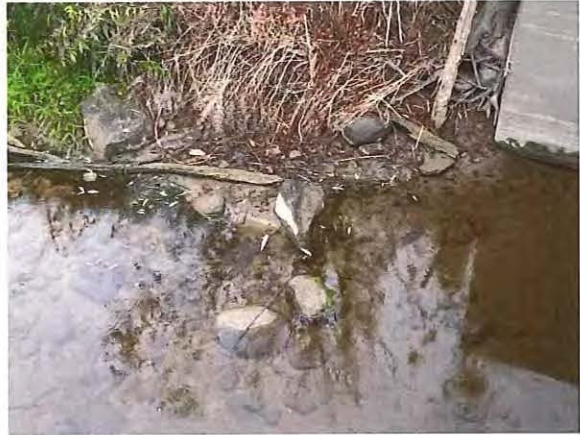
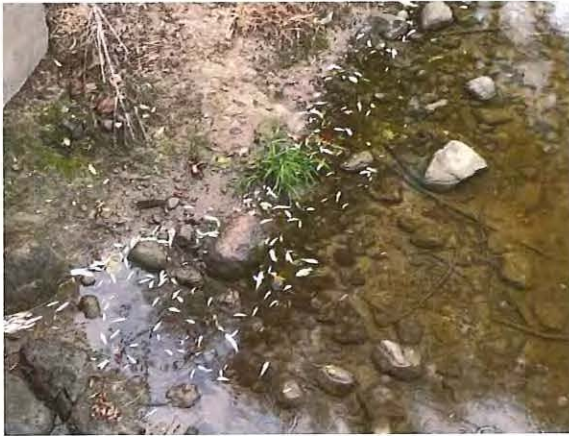
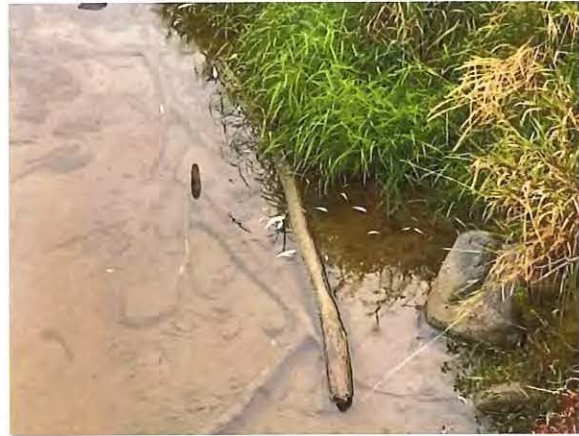
Figure 2. Officer Wright's daytime photographs.

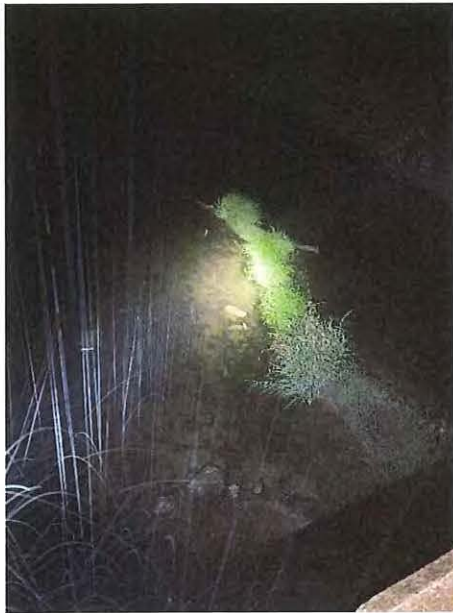
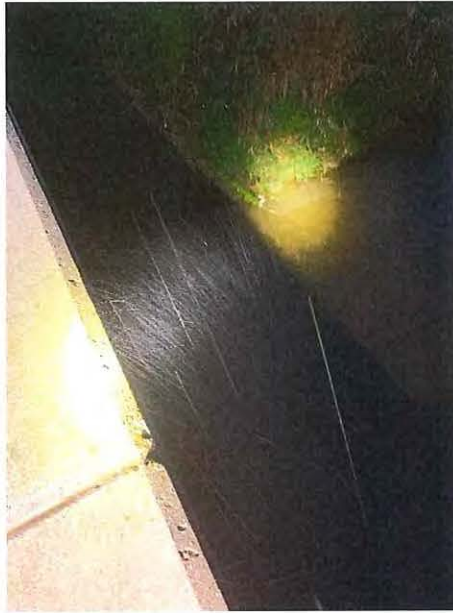
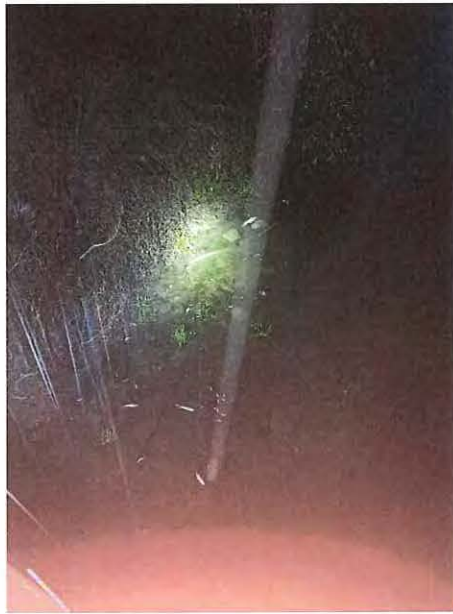
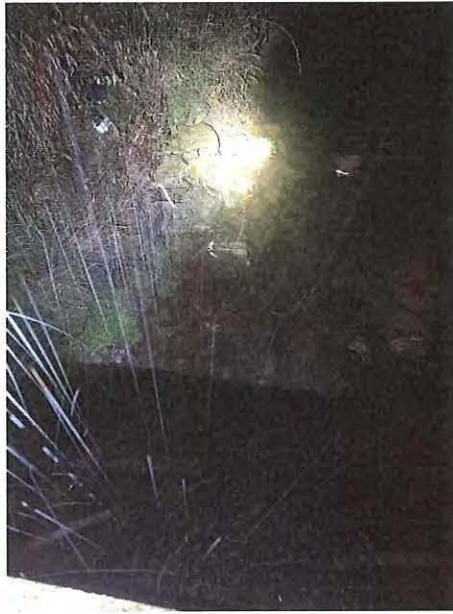
Figure 3. Officer Wright's nighttime photographs.

This report is in response to an incident that was first reported on 12 September 2021. Josh Wright, MDNR Tuscola County Conservation Officer, received a complaint on 12 September 2021 from Tuscola County Dispatch reporting there were thousands of dead fish near the address of 5410 Shabbona Road, Novesta Township, Tuscola County. Officer Wright arrived at North Branch White Creek at the Phillips Road stream crossing that afternoon, where he observed dead fish floating in and on the bottom of the stream. He proceeded upstream to each road stream crossing to look for additional dead fish; he observed dead fish at McArthur Road, North Cemetery Road, North Englehart Road, Crawford Road, Shabbona Road, and Deckerville Road (Figure 1). Based on photographs Officer Wright submitted to Fisheries Division, it appears there were between 1 and 100 dead fish at each site, with lower numbers occurring further upstream in his investigation (Figure 2; Figure 3; Figure 4). It began raining during Officer Wright's investigation, which can be observed in his photographs; this likely transported some dead fish further downstream between the time of his observations and my follow up investigation the next day (Figure 3; Figure 4).

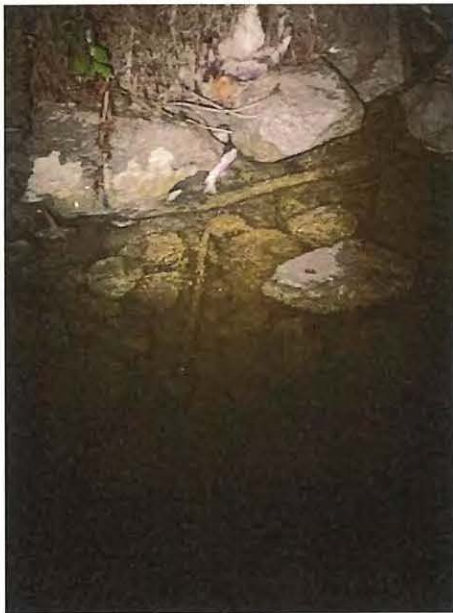
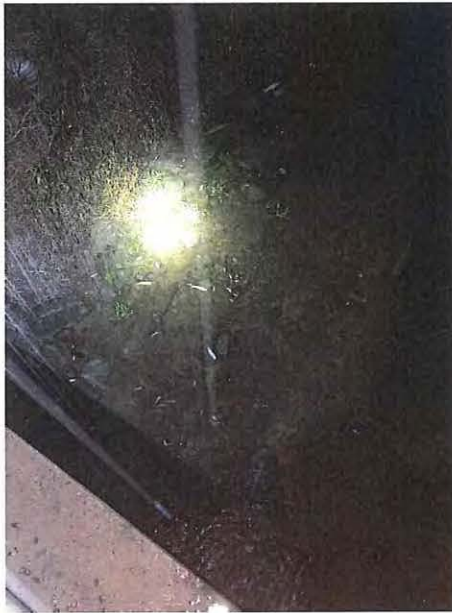
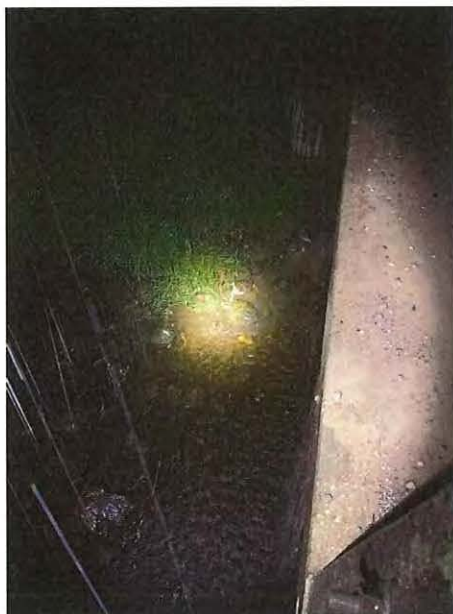
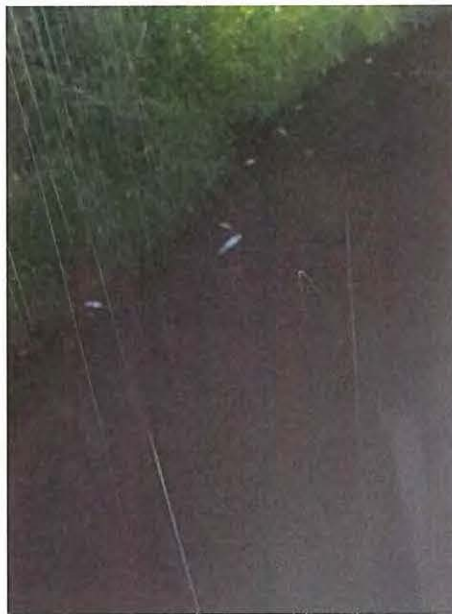
Figure 4. Additional nighttime photographs from Officer Wright.

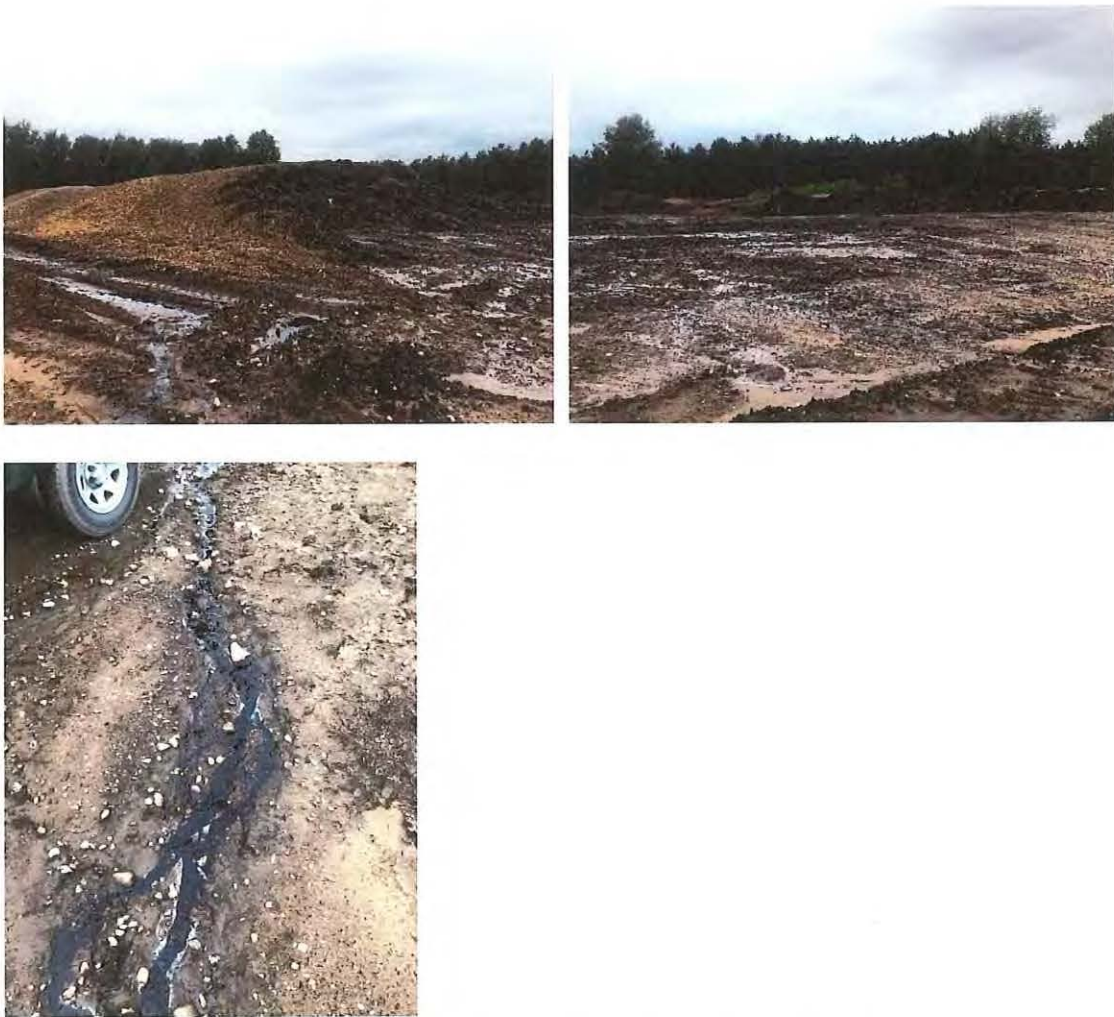
Figure 5. Agricultural waste (top panels) and leachate (bottom panel) at the contamination site (N 43.5070, W -83.1097).

We then traveled to the next upstream crossing site at North Lamton Road (N 43.5052, W -83.1097). The DO level at this location was above 6 mg/L. This data indicated the upstream boundary of the affected area. From this stream crossing we observed mounds of unidentifiable material adjacent to the stream which we thought might be contributing to the low DO levels we observed. We traveled along an access road toward the mounds to determine their composition. As we approached the site, we observed leachate from the mounds entering North Branch White Creek (Figure 5); the site of this leachate was 6.9 mi upstream from the initial observations by Officer Wright at 5410 Shabbona Road, Novesta Township, Tuscola County. Moreover, we visually identified the mounded material as agricultural waste; there was also evidence of animal remains present. Leachate from agricultural waste can lead to a lethal environment for fish if it meets surface water. Agricultural waste leachate has a high biological oxygen demand and quickly uses up the available oxygen in surface water, creating a hypoxic system with low DO, or even an anoxic environment devoid of DO (Loehr 1974; Loehr 1977). Using map applications and aerial imagery we estimated the agricultural waste storage area spanned approximately 3 acres. The material was being stored at a higher elevation than the surrounding field with no structures in place to prevent leachate from entering North Branch White Creek.

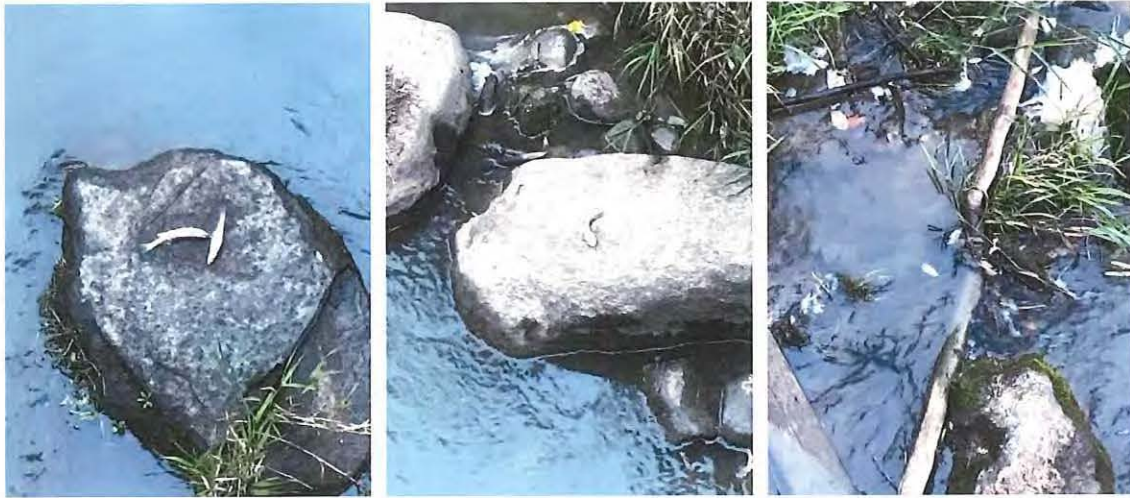
Figure 6. Dead fish observed at Shabbona Road (N 43.5296, W -83.1267).

After gathering information and photographs at this site, at 19:15 I traveled downstream to the road crossings where Officer Wright previously observed dead fish. In total, I documented dead fish at four road crossings (Table 2, Figures 6, 7, 8, and 9). Species were visually identified

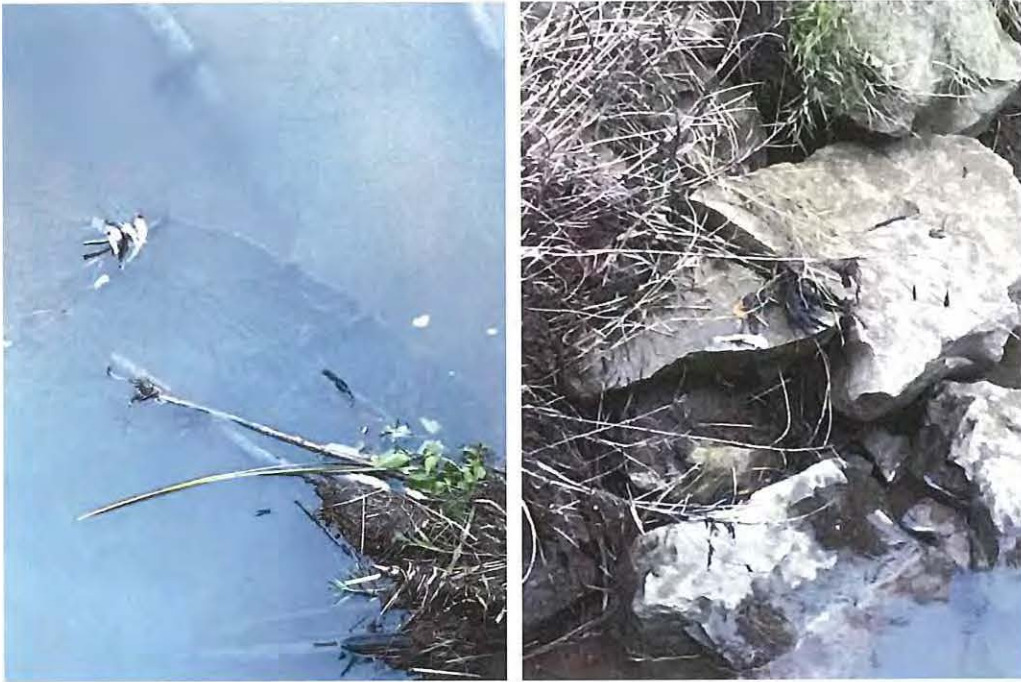
Figure 7. Dead fish observed at Crawford Road (N 43.5386, W -83.1315).

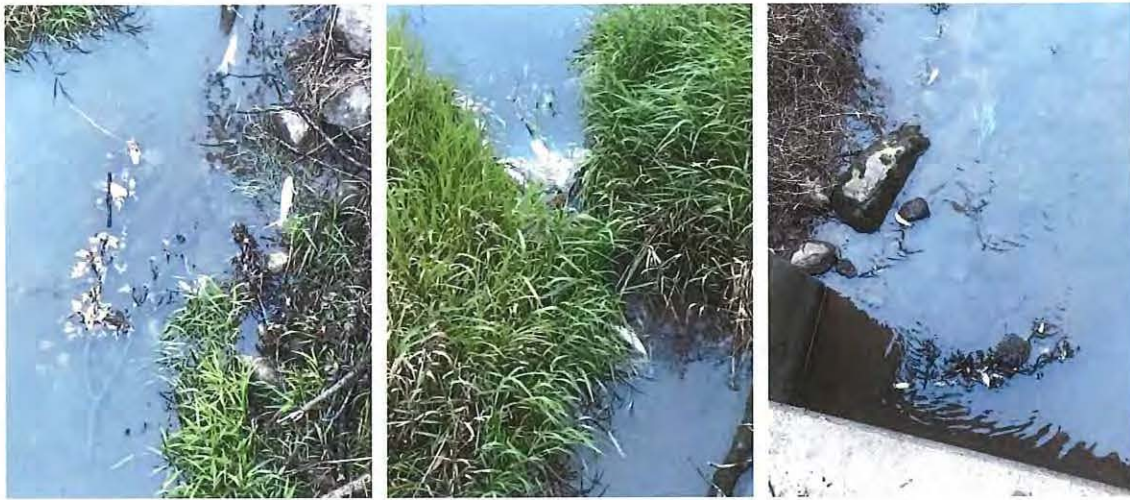
Figure 8. Dead fish observed at North Englehart Road (N 43.5339, W – 83.1512).

and counted from the road. During this portion of my investigation, I spoke with one property owner who lived adjacent to the Englehart Road crossing (N 43.5339, W -83.1512). The citizen explained seeing “thousands” of dead fish along the streambank over the weekend but described how they had all washed away with the heavy rains over the past 48 hours. At the Englehart Road crossing, I observed primarily minnows of various species, a few panfish and suckers, and one Northern Pike. Based on the citizen’s account of the previous few days, it seemed that most of the dead fish had already been pushed downstream by the previous days’ high discharge rain event. The United States Geological Survey has a stream monitoring station along the Cass River in Wahjamega, Michigan, downstream of the confluence between White Creek and the Cass River. The estimated height of the Cass River before this rain event was approximately 3.1 ft on 12 September 2021, and it increased to approximately 3.5 ft on 13 September 2021, an increase of over 4.5 in (Figure 10). Additionally, the Tuscola Area Airport Weather Station recorded 1.4 in of rainfall on 12 September 2021, and this rain event likely transported dead fish downstream before I investigated these sites the following day. Fading light and an approaching thunderstorm also prevented me from traveling to all seven sites where Officer Wright had previously observed dead fish.

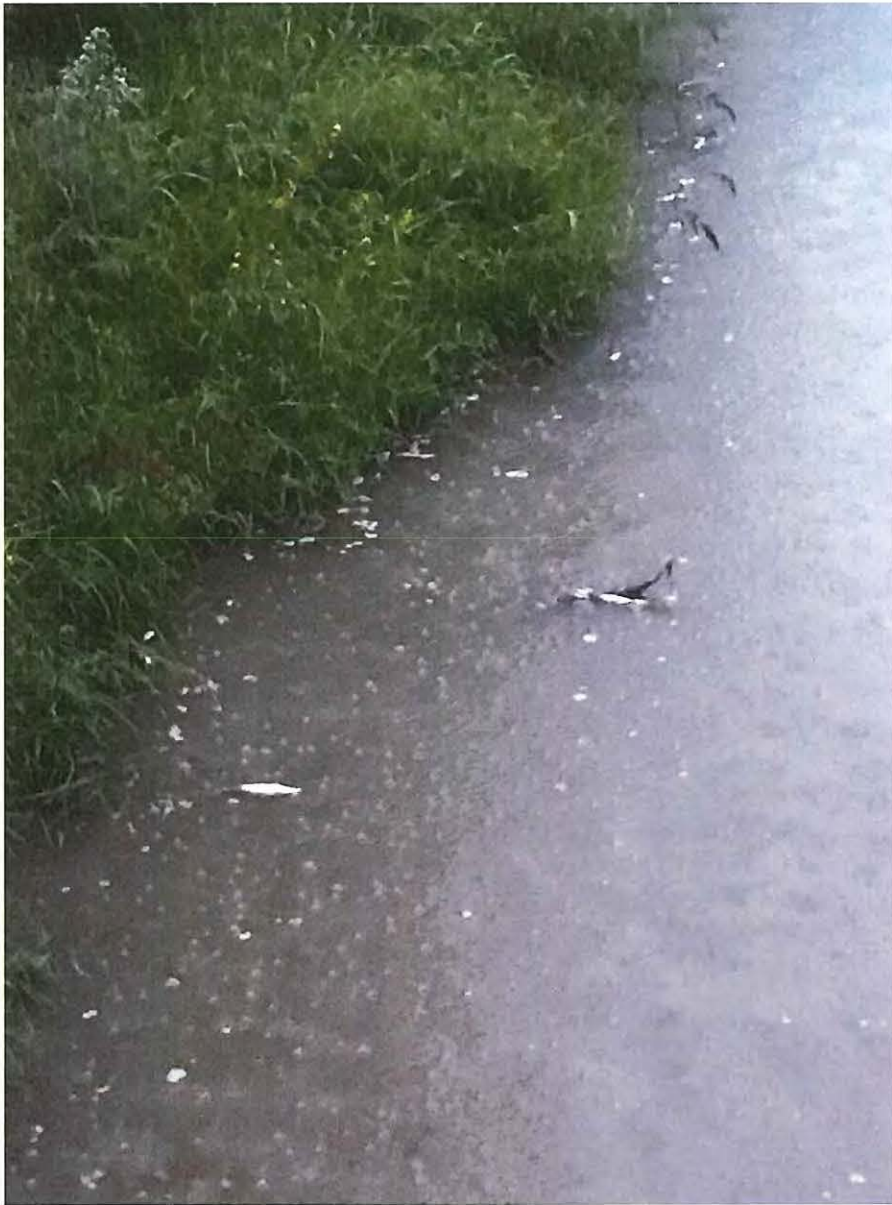
Figure 9. Dead fish observed at North Cemetery Road (N 43.5319, W -83.1719).

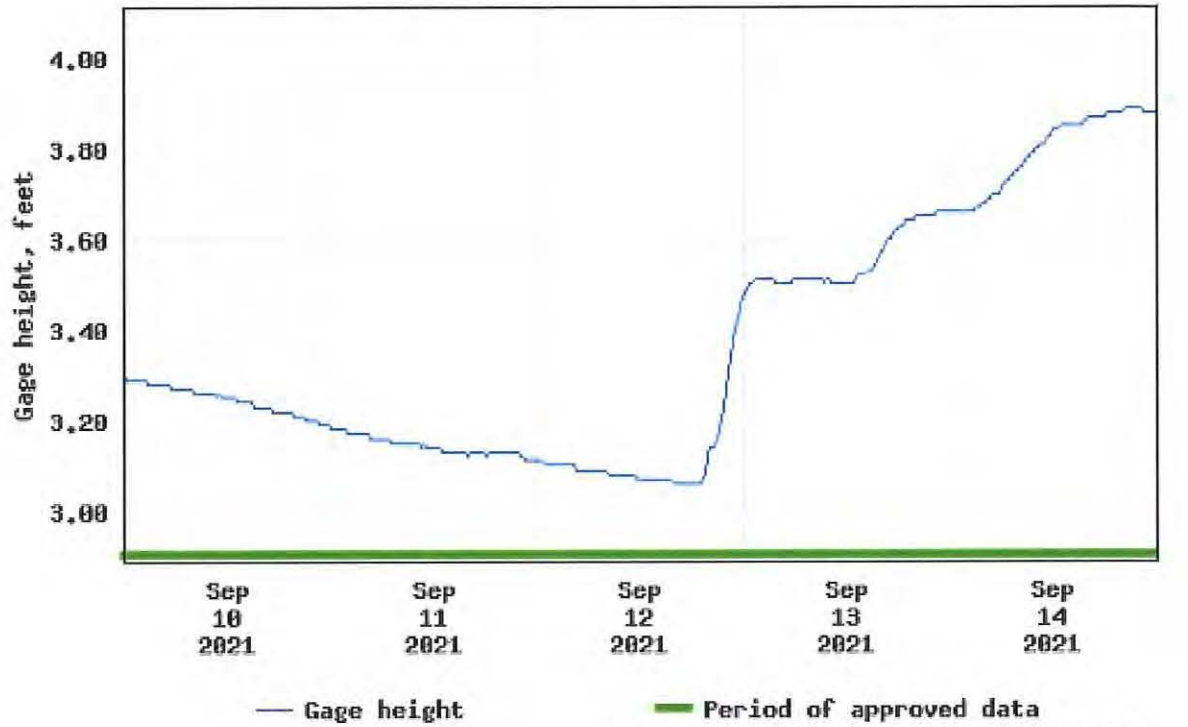
Figure 10. Gage height for United States Geological Survey stream monitoring station in the Cass River at Wahjamega, Michigan from 10 September 2021 to 14 September 2021.
