Michigan Department of Transportation

Surface Condition of Active Networks (SCAN): Assessment Ratings for Shared Use Paths

Version 1.0 – Updated Nov. 15, 2024

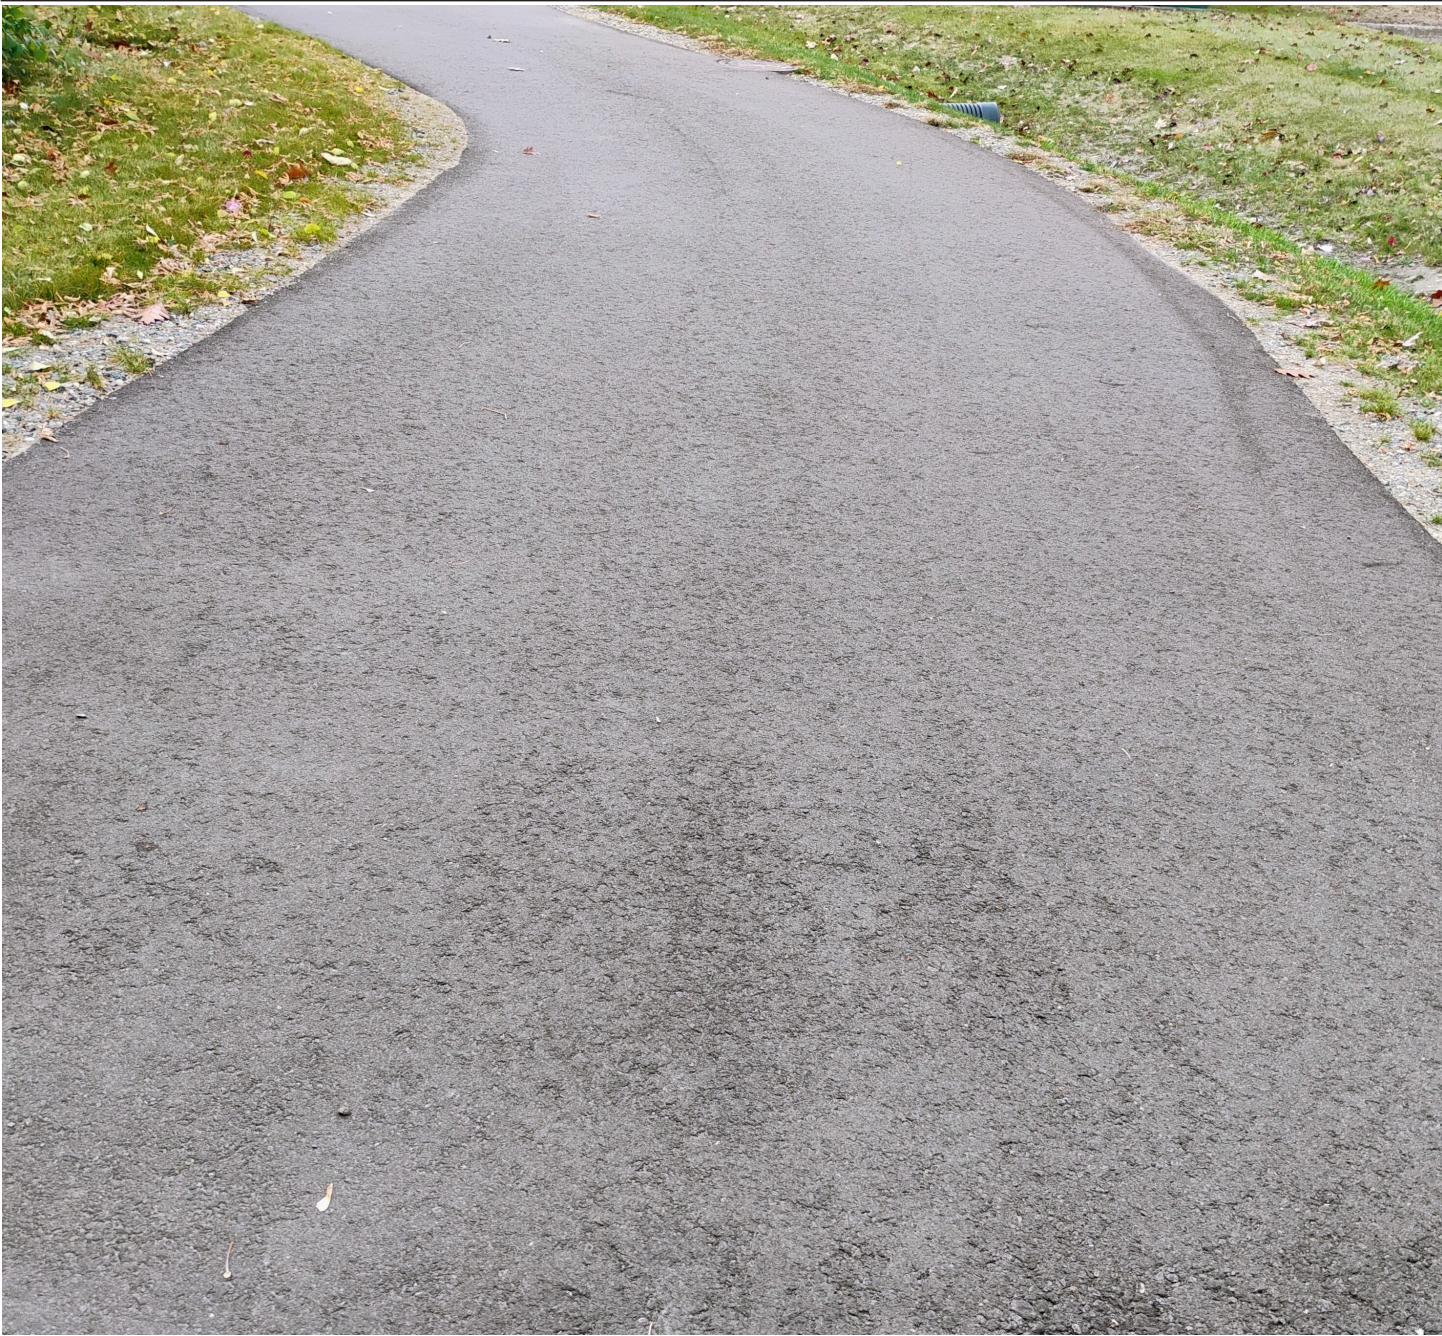
Rating Scale	General Condition and Visible Distress	Treatment Measures
5 Very Good	<p>The pavement is new construction or recent overlay. There is little to no maintenance required.</p> <ul style="list-style-type: none">• No cracking.• Slight oxidization.	<ul style="list-style-type: none">• Fog seal

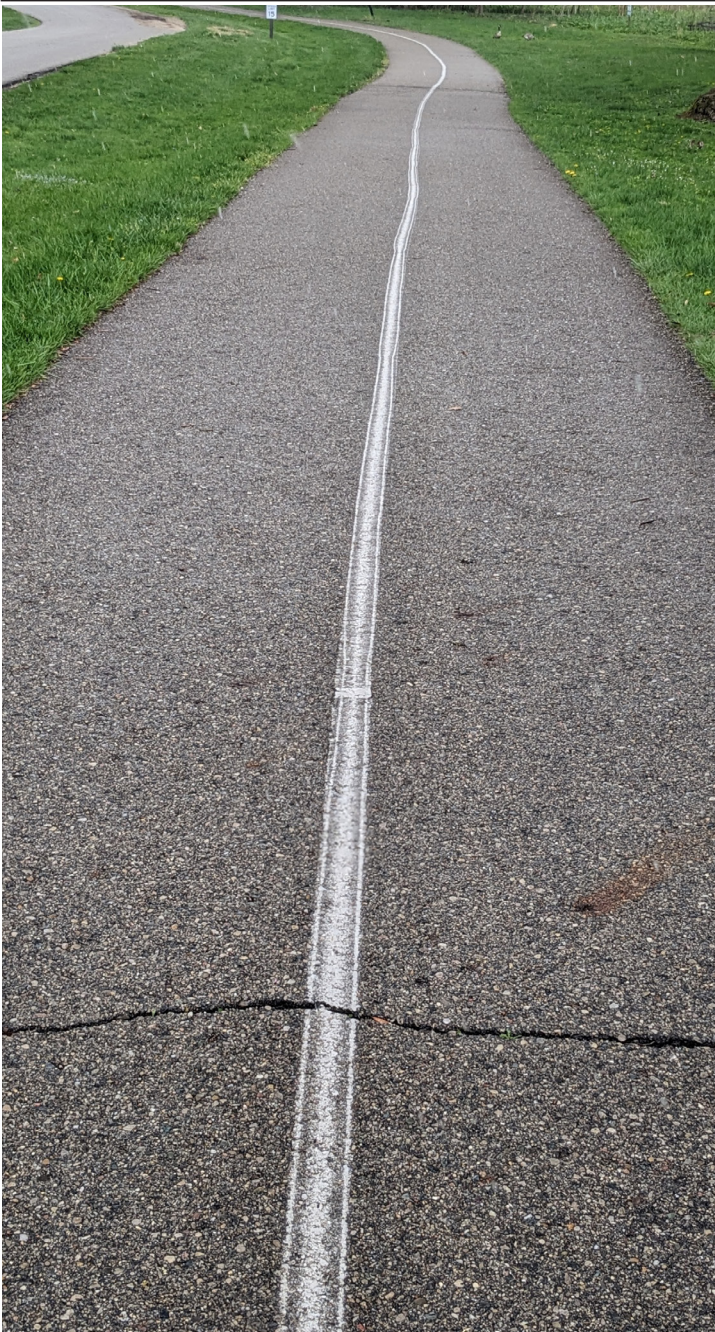
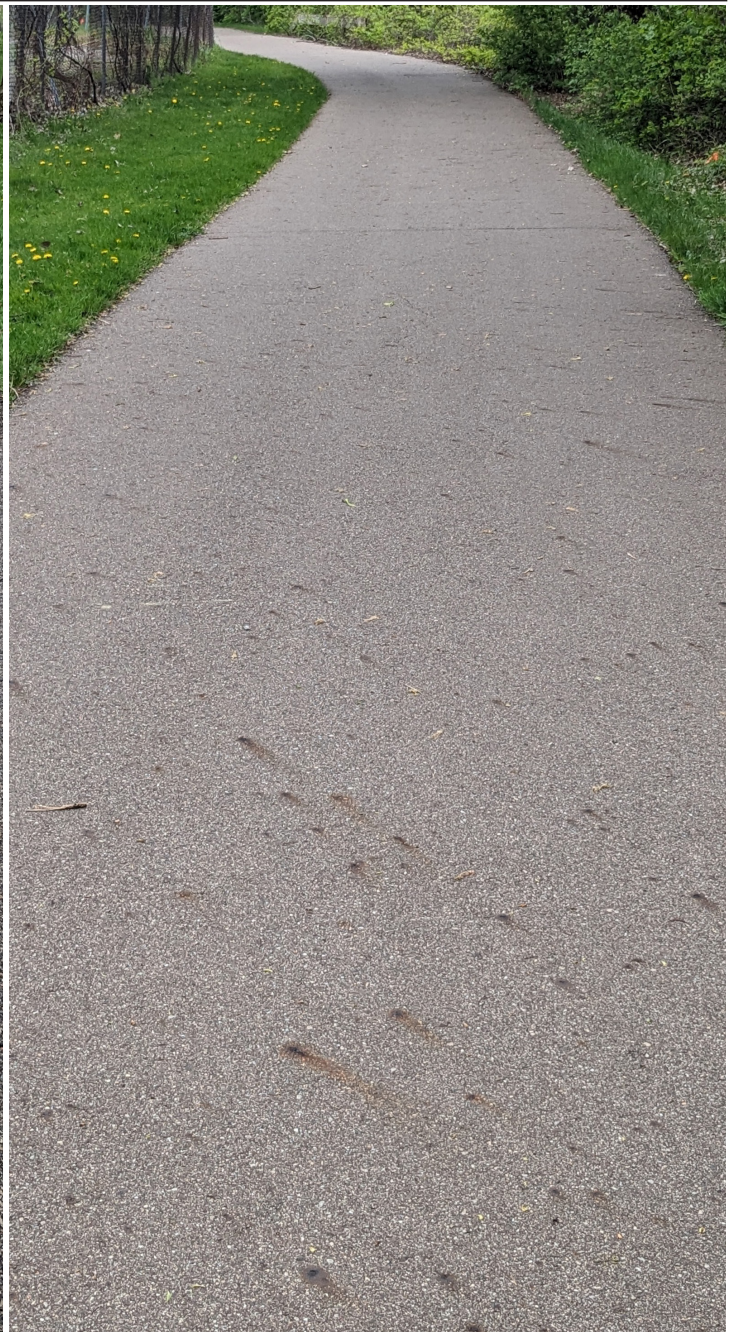
Rating Scale	General Condition and Visible Distress	Treatment Measures
<p style="font-size: 48pt; font-weight: bold; text-align: center;">4</p> <p style="font-size: 24pt; font-weight: bold; text-align: center;">Good</p>	<p>The pavement is showing first signs of aging and still in sound structural condition. Maintain with crack sealing and pavement sealing.</p> <ul style="list-style-type: none"> • Occasional transverse cracks (10 feet or more apart). Open one-quarter inch or less. • Occasional longitudinal cracks. Open one-quarter inch or less. • Very slight or no crack heaving (from vegetation) or crack cupping. • Very slight or no raveling. • No patching. • Good drainage, no standing water. 	<ul style="list-style-type: none"> • Route and seal cracks (flush fill) • Fog seal • Micro-surface

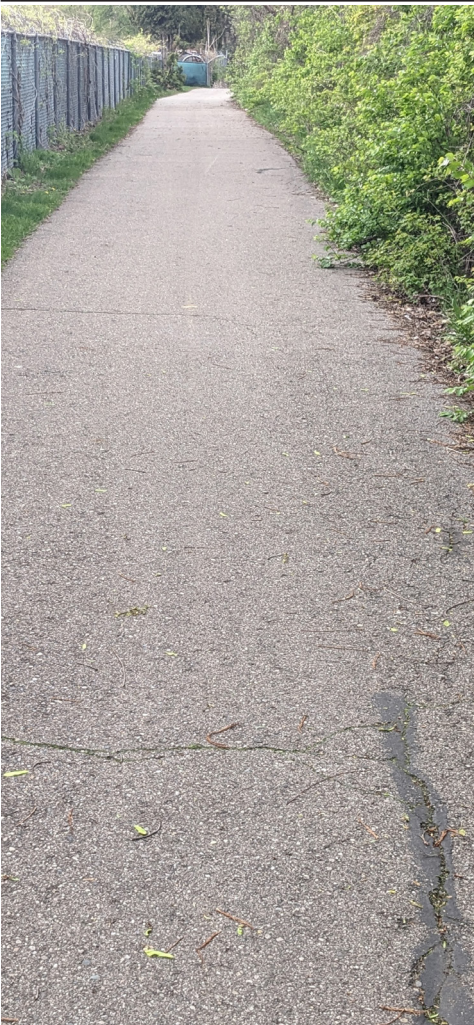
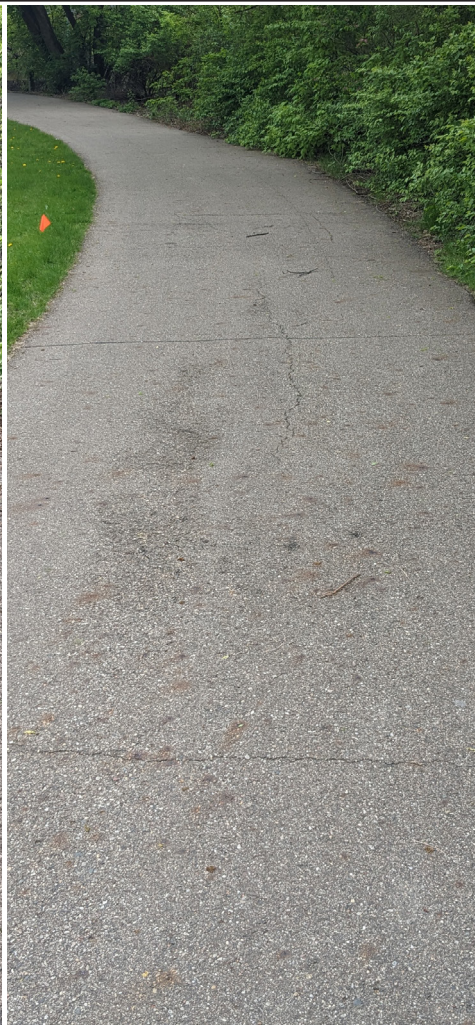
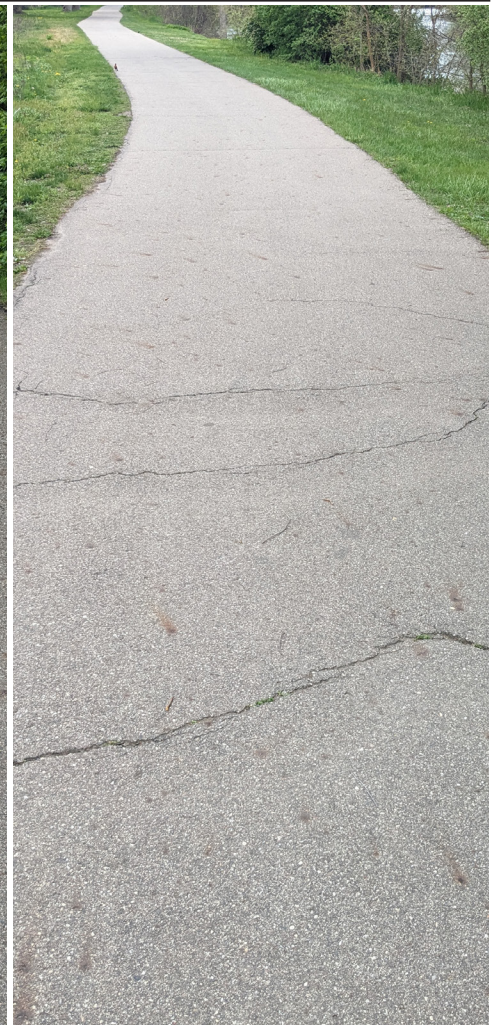
3
Fair

The pavement is showing signs of surface aging and is in sound structural condition. Maintain with crack sealing and pavement sealing. Vegetation management should be reviewed.

- Transverse cracks (some spaced less than 10 feet apart). Open one-half inch or less.
- Longitudinal cracks. Open one-half inch or less.
- Moderate crack heaving (from vegetation) or crack cupping less than 1 inch. Note isolated sites of greater depth.
- Uneven profile of less than one-half inch. Note isolated sites of greater depth.
- Low to moderate raveling.
- Some patching. In good condition.
- Very slight or no vegetative encroachment.
- Note isolated sites of poor drainage.

- Route and seal cracks (flush fill)
- Mastic
- Remove and replace crack heaving/crack cupping locations
- Micro-surface
- Clear encroaching vegetation
- Improve isolated sites of poor drainage

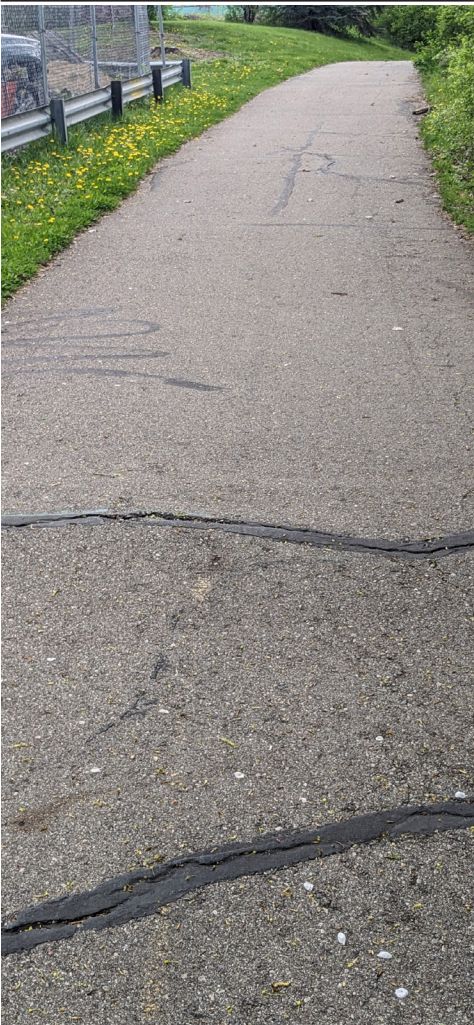
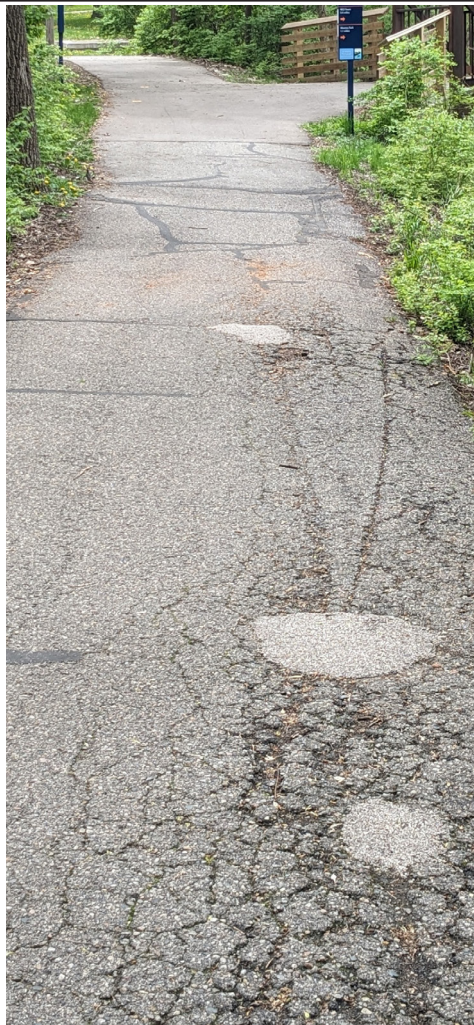
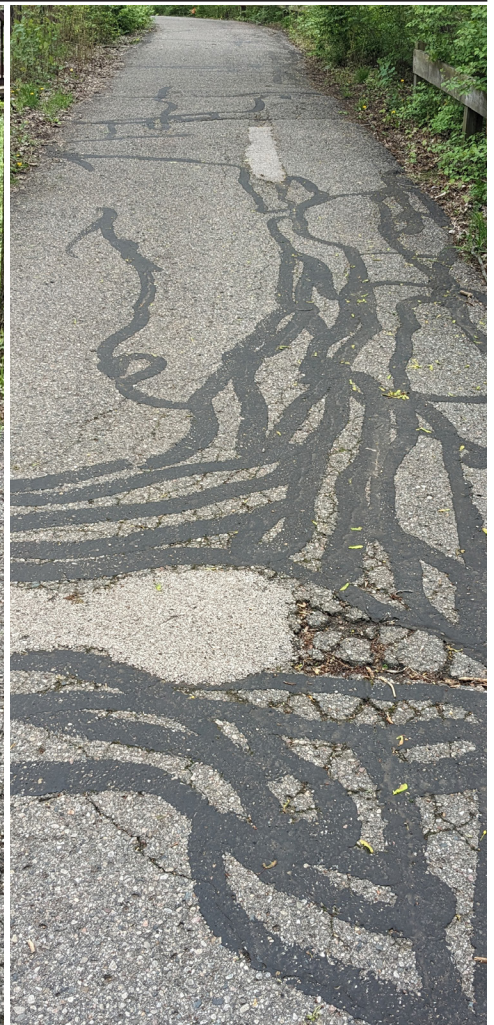
2
Poor

The pavement is showing significant aging. Pavement repairs and patching will be needed prior to an overlay. Vegetation management and drainage should be reviewed.

- Closely spaced longitudinal and transverse cracks.
- Block cracking up to 50 percent of surface.
- Some alligator cracking (less than 25 percent of surface).
- Moderate uneven profile of one-half to 2 inches.
- Severe crack heaving (from vegetation) or crack cupping greater than 1 inch.
- Patches in poor to fair condition.
- Occasional potholes.
- Vegetative encroachment on pavement greater than 4 inches.
- Poor drainage, standing water.

- Remove and replace crack heaving/crack cupping locations
- Mastic
- Remove and replace crack heaving/crack cupping locations
- Micro-surface
- Clear encroaching vegetation
- Drainage improvements

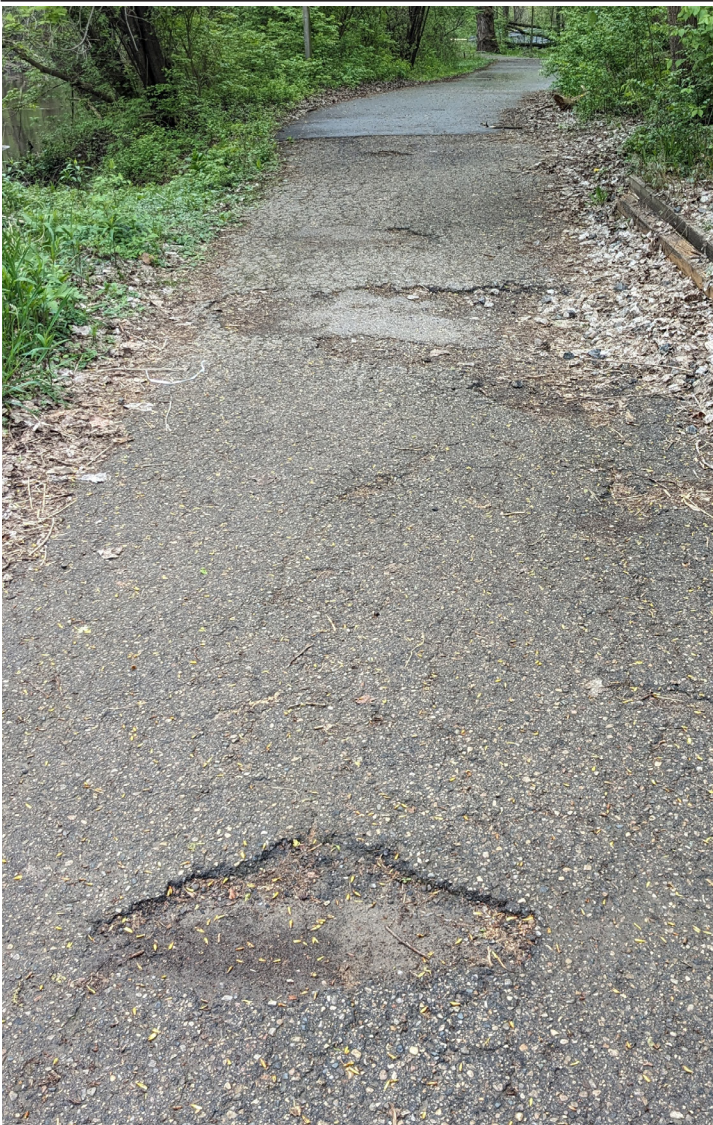
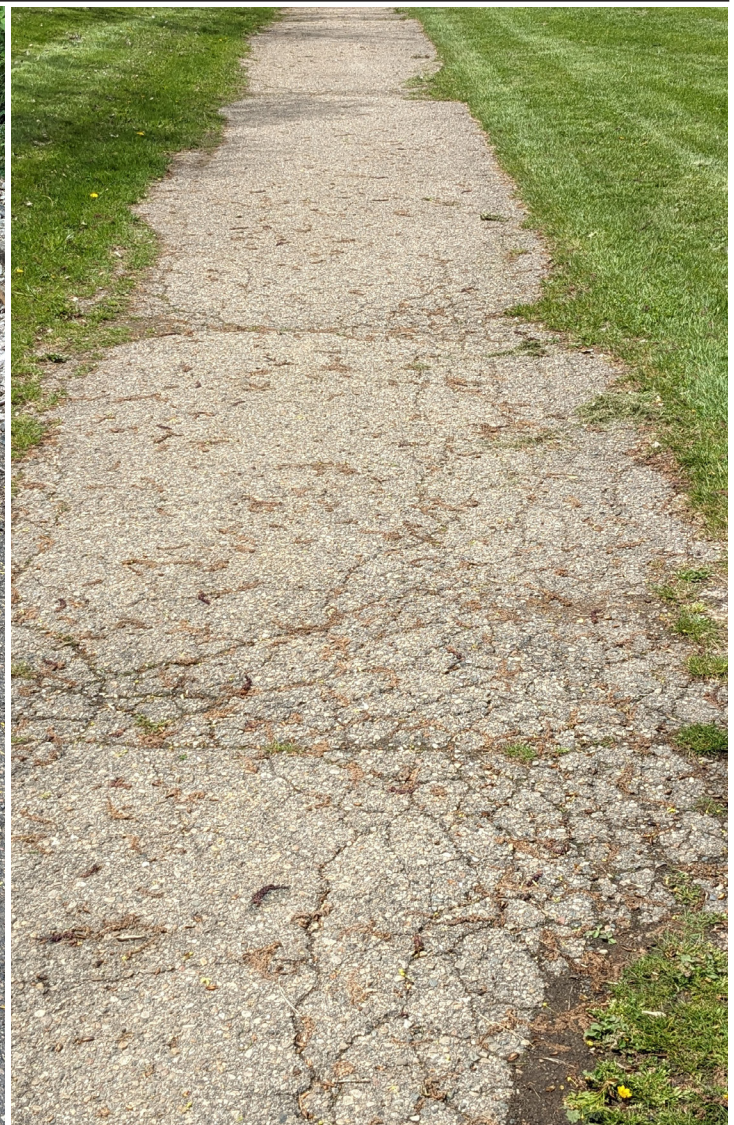
Very Poor

The pavement is showing severe deterioration. Needs reconstruction. Review soil conditions for any stabilization. Vegetation management and drainage should also be reviewed.

- Severe block cracking (greater than 50 percent of the surface).
- Severe alligator cracking (over 25 percent of the surface).
- Severe uneven profile of 2 inches or more.
- Severe crack heaving (from vegetation) or crack cupping greater than 1 inch.
- Extensive patching in poor condition.
- Potholes.
- Vegetative encroachment on pavement greater than 6 inches.
- Poor drainage, standing water in multiple locations.

- Reconstruction
- Vegetation removal
- Drainage improvements

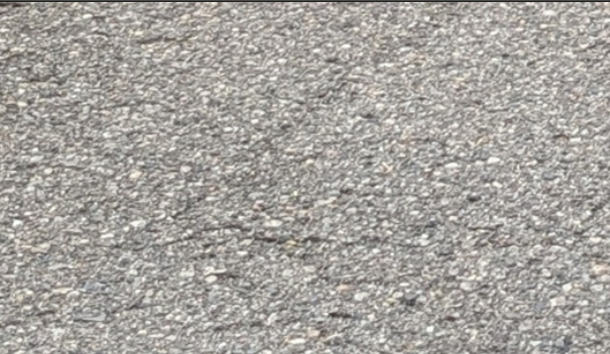
Surface Defects		
Type	Definition	Example Photograph
Raveling	Raveling is the wearing away of the pavement surface caused by the dislodging of aggregate particles and loss asphalt binder. Slight to moderate raveling has loss of fines. Severe raveling has loss of coarse aggregate, ultimately leading to a very rough and pitted surface with obvious loss of aggregate.

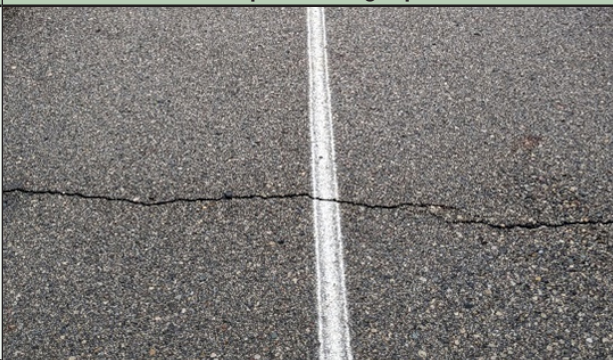
Type	Definition	Example Photograph
Transverse	Crack that are predominantly perpendicular to the pavement centerline. They are often regularly spaced. The cause is movement due to temperature changes and hardening of the asphalt with aging.

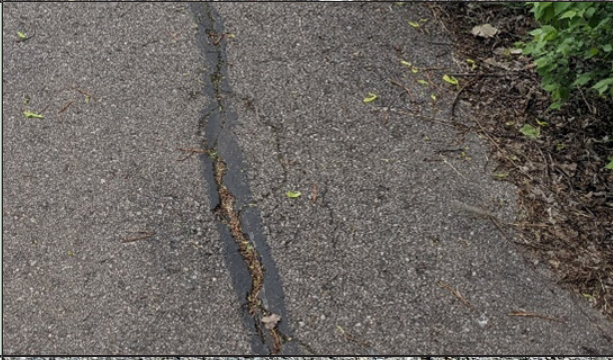
Longitudinal	Cracks predominately parallel to the pavement centerline. Cracks within 1 foot of the edge are caused by insufficient shoulder support, poor drainage or frost action. Cracks usually start as hairline or vary narrow and widen and erode with age. Without crack filling, they can ravel, develop multiple cracks and become wide enough to require patching.

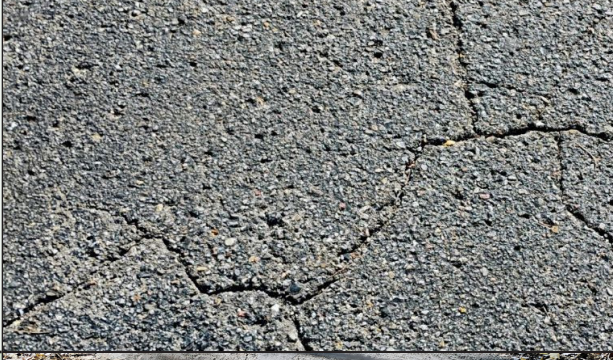
Block	A pattern of cracks that divides the pavement into approximately rectangular pieces. Blocks may range from 1 foot to approximately 10 feet or more across. The closer spacing indicates more advanced aging caused by shrinking and hardening of the asphalt over time.

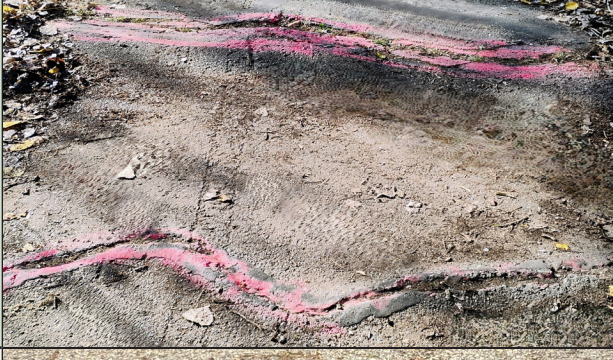
Heaving/ Cupping	Heaving is a series of elevated cracks causing an uneven surface, usually caused by underlying tree roots. Cupping is a channel-like depression along a crack caused by the deterioration of the base material. This may be a gentle swale or a fairly severe dip.

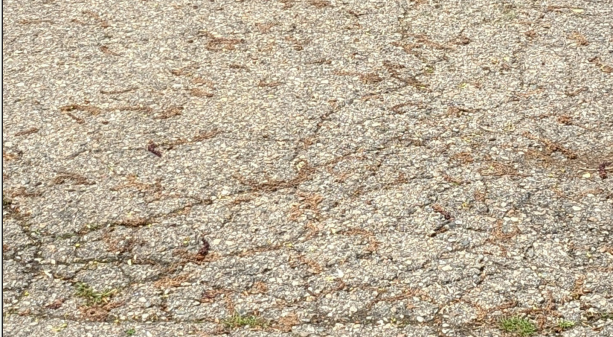
Alligator	A series of interconnected cracks forming small pieces ranging in size from about 1 to 6 inches. On shared use paths, this is often due to inadequate base or subgrade support.

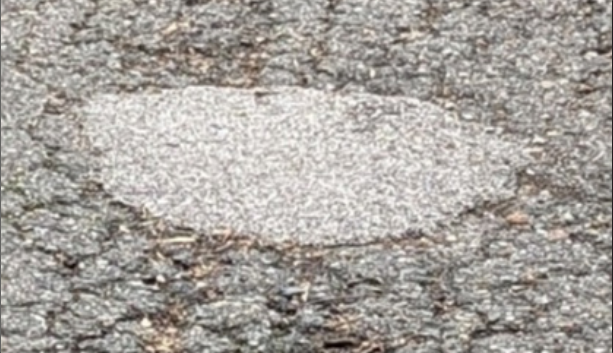
Other		
Type	Definition	Example Photograph
Patches	Original surface repaired with new asphalt patch material. This indicates a pavement defect or utility excavation that has been repaired. Patches with cracking, settlement or distortions indicate underlying causes still remain.

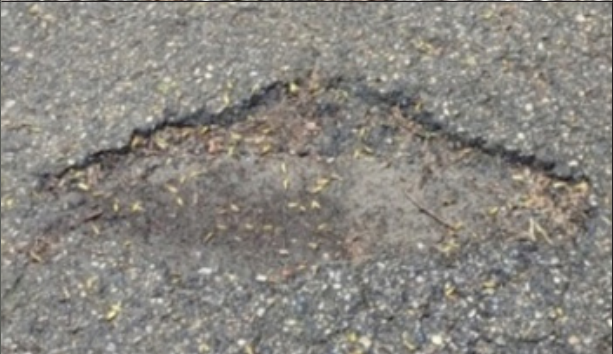
Potholes	Bowl-shaped holes of various sizes in the pavement surface. Holes and loss of pavement material caused by fatigue and inadequate strength. Often combined with poor drainage.

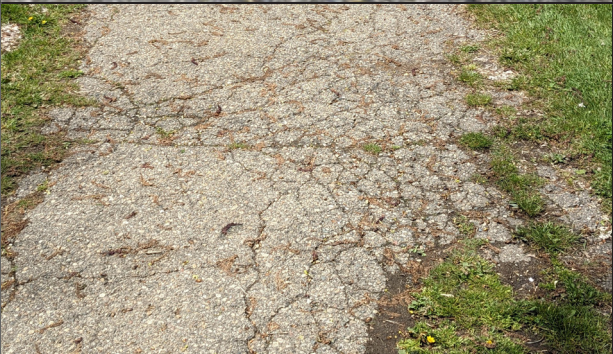
Vegetative Encroachment	Refers to the growth of vegetation over an improved surface at ground level. This can reduce useability, create safety hazards and cause premature deterioration.
