PORT HURON STUDY
Historical Development of Hydrocarbons
and Subsequent Problems

Walter Danyluk,
Michigan Department of Natural Resources
Geological Survey Division

1990

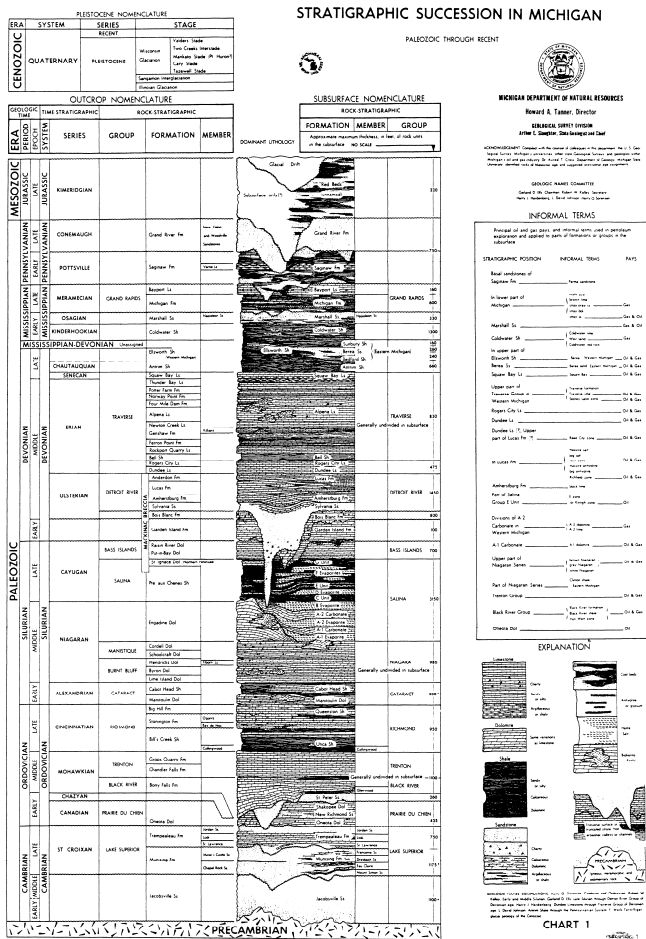
wellbore in the Dundee, Antrim, or Glacial Drift and migrate to upper zones, or to the surface. The same can occur in old salt wells (B), except here even more formations are involved. A good portion of the Case Histories represent this scenario.

Industrial wastes injected down a disposal well (C) can migrate, or thru increased pressure force formation fluids to migrate laterally in the Detroit River formation and enter old salt wells (B), or migrate into the Dundee formation thru fractures and eventually enter old Dundee wells (A). Actual access to the well-bore is the same as described for old Dundee wells.

Deeper, more recent Niagaran wells (E) provide other potential avenues for gas/fluid migration into higher rock formations, or to the surface. Again, entry into the wellbore occurs in portions of the hole that may not be cased, cased but corroded, or improperly plugged. Case History 44 is an example.

Storage well (F) operations can also create potential for subsurface/surface problems if there is leakage from the storage zone which may overpressurize surrounding rock formations and initiate or alter gas/fluid migration.

The old Dundee well (A) shows that if the well is not (properly) plugged, or not cased at all, or cased but corroded/damaged, fluids and gas can enter the
