# Brown Bridge Dam – Temporary Dewatering Structure

## Root Cause Analysis of the October 6, 2012, Failure Incident

June 2014

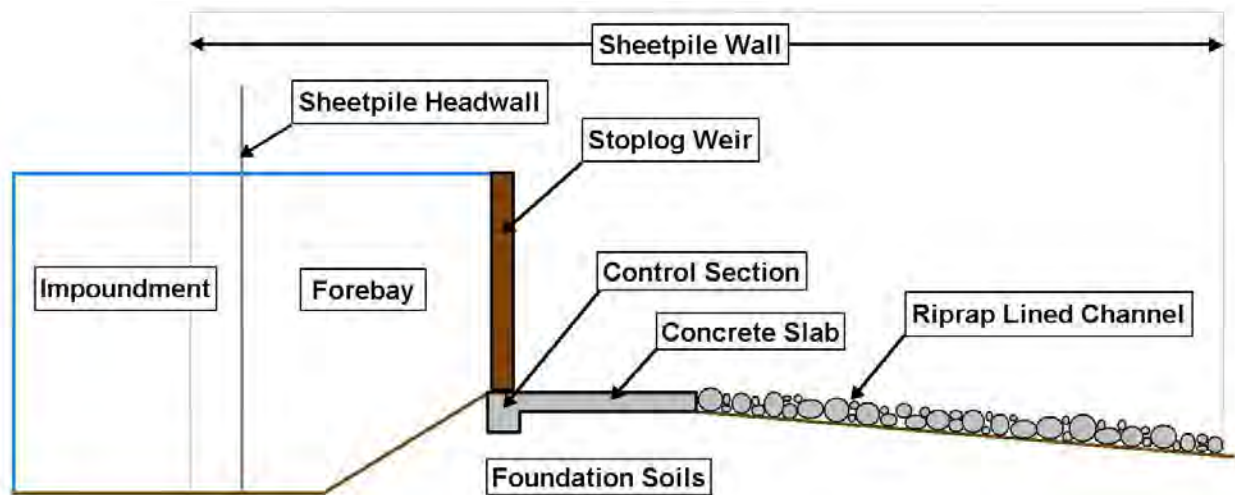
**Figure II-1.** Profile view of TDS construction

To complete the drawdown of the impoundment, a TDS was constructed immediately right of the powerhouse/spillway structure. The TDS consisted of steel sheetpile side walls, a concrete control section, two timber stoplog bays, and a riprap-lined channel downstream of the control section, as shown in Figure II-1 below.

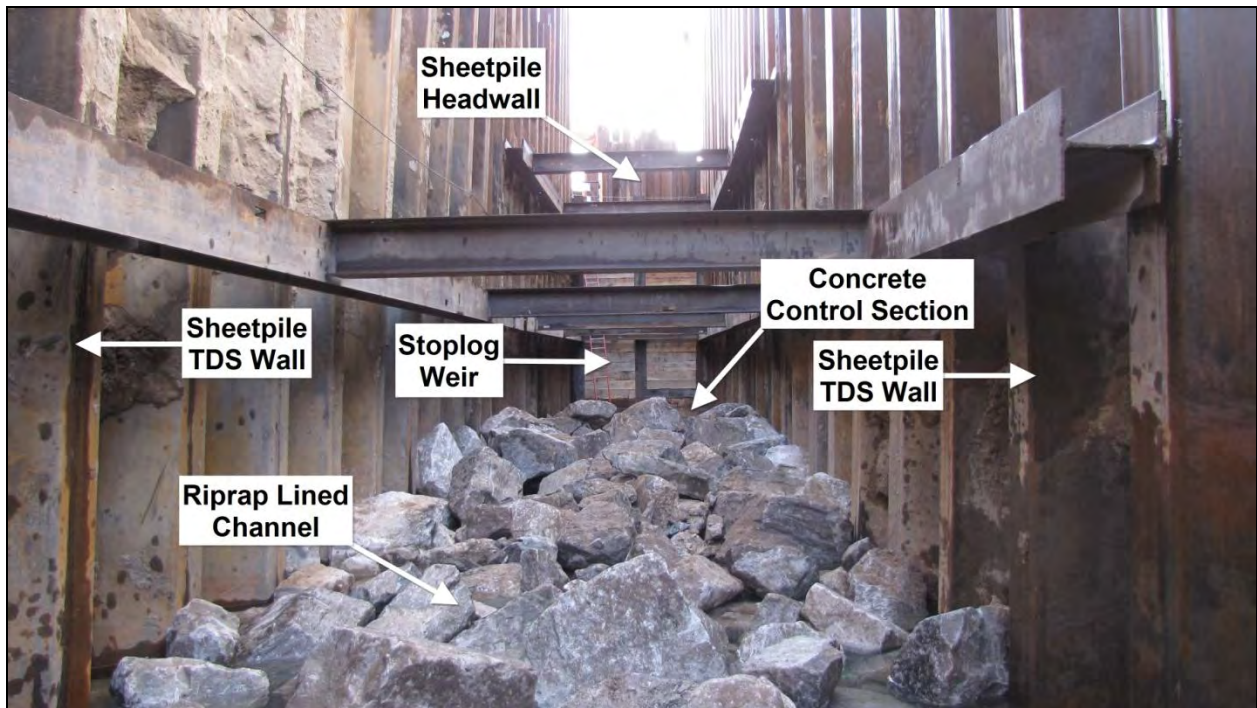
**Figure II-3.** Diagram of TDS structure viewed from downstream  
*Photo courtesy of AMEC*

During construction of the TDS, a steel sheetpile headwall was installed at the inlet to prevent flow into the structure. Embankment material was then excavated from between the TDS walls, and construction of the control structure and downstream channel was completed in early October. Testing of the structure and continuation of the drawdown was scheduled to begin on Saturday, October 6, 2012. A photographic diagram of the completed TDS structure is shown in Figure II-3 below.

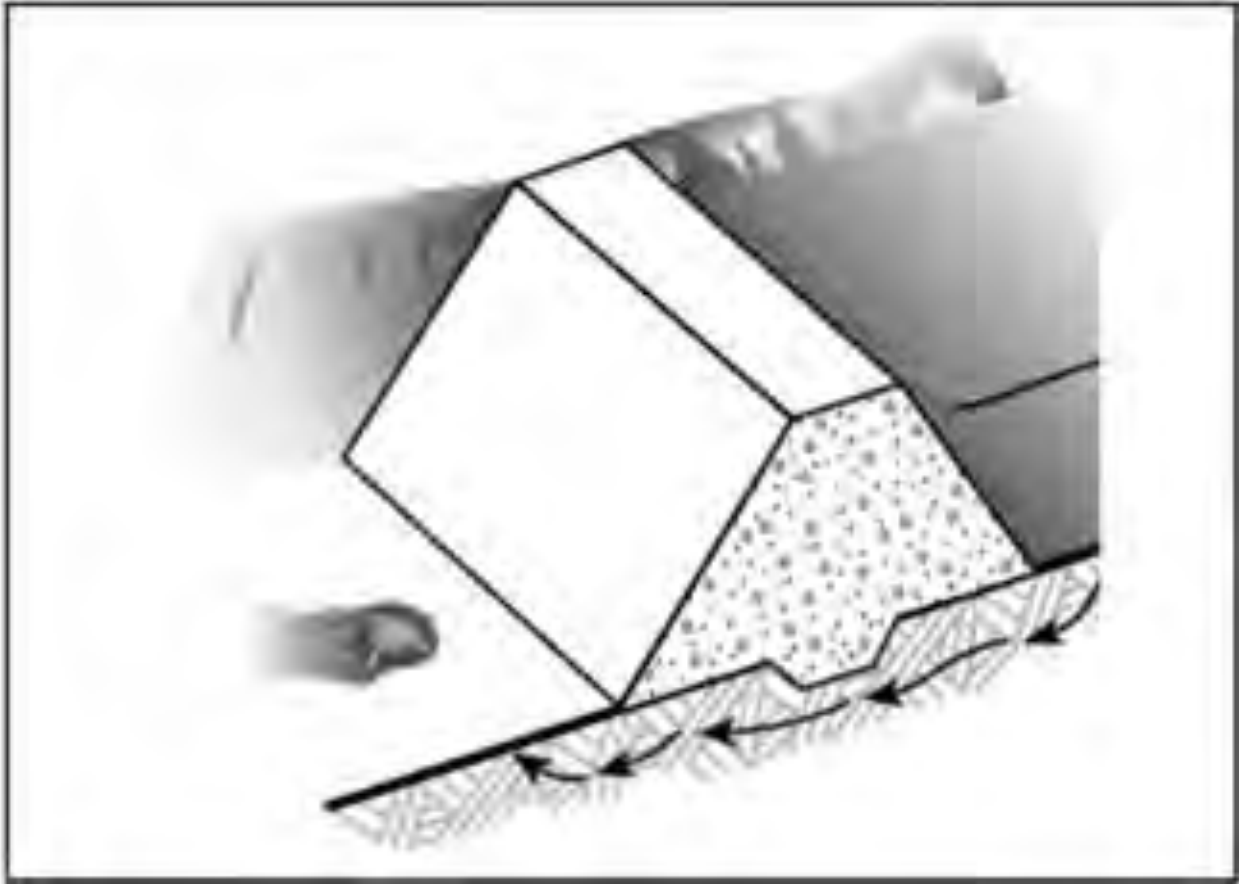
**Figure III-3.** Diagram of a foundation piping and sand boil formation  
*Source: Dam Safety: An Owner's Guidance Manual*

Three possible primary failure modes were considered as part of this analysis. The first failure mode considered was that a pipe formed in the embankment/foundation material directly underneath the TDS control section, eventually leading to the uncontrolled release of water and sediments through the TDS, breaching of the left adjacent embankment section, and total failure of the dam. A diagram of piping through the foundation of a dam is shown in Figure IV.3 below.

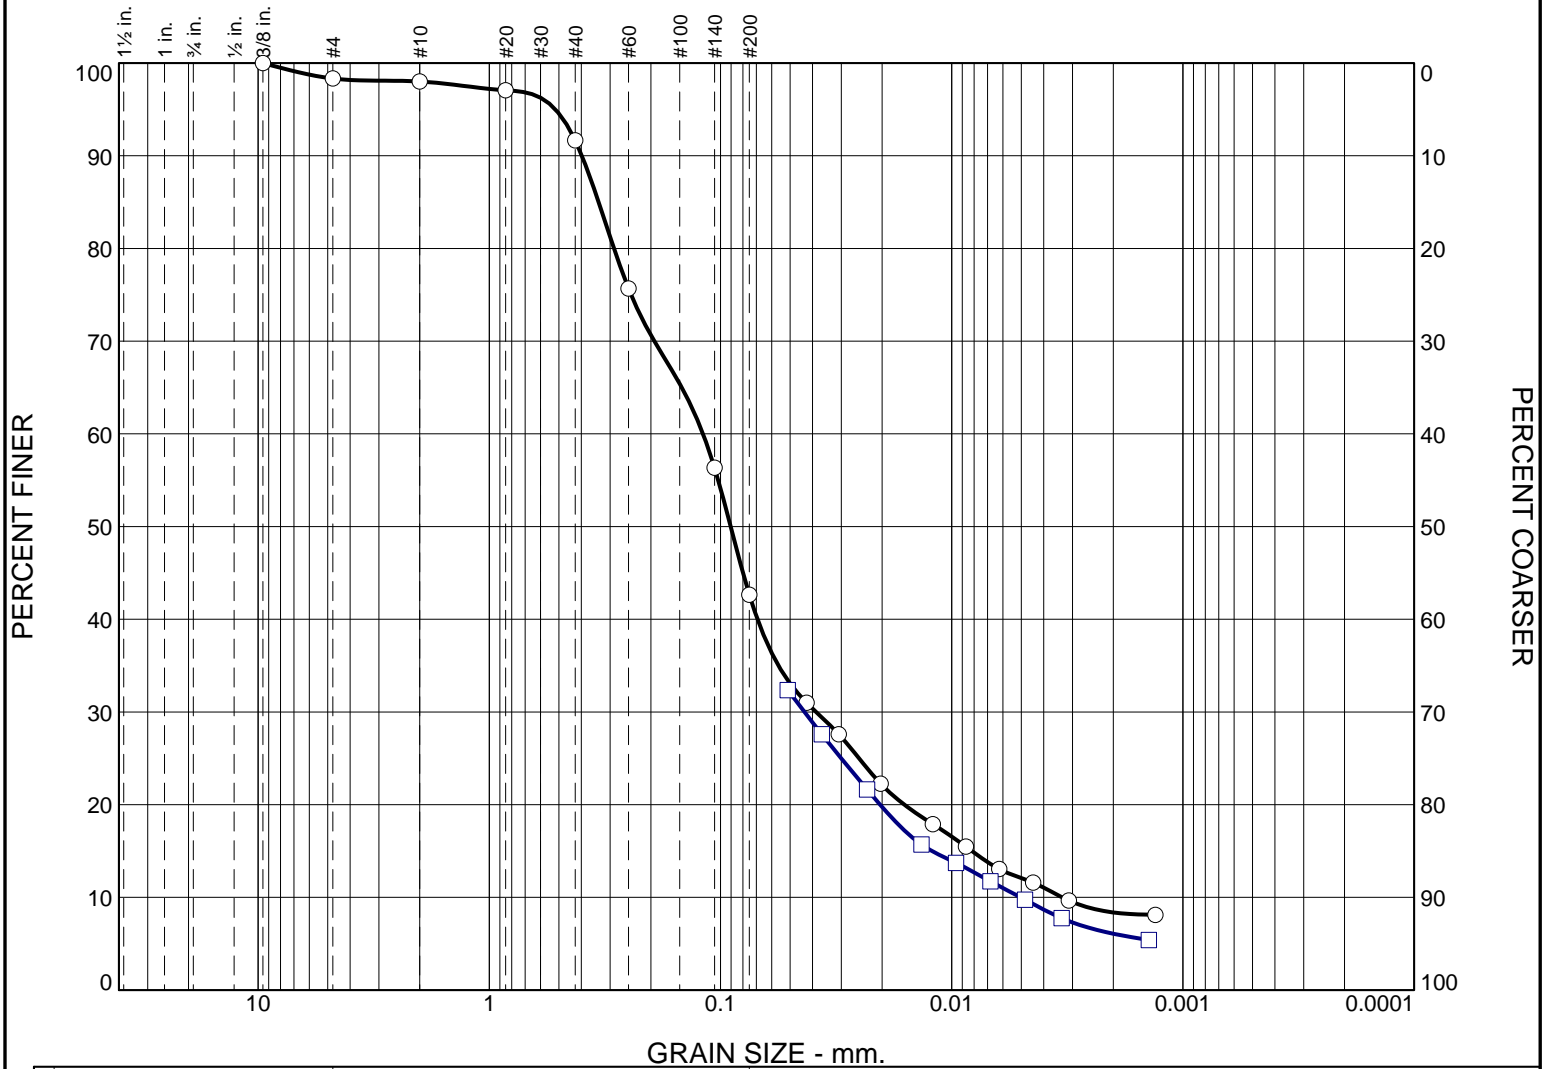
<b>Project No.</b> 60279499 <b>Client:</b> GARAN LUCOW MILLER, P.C <b>Project:</b> BROWN BRIDGE DAM  ○ <b>Source of Sample:</b> B-GB-13 <b>Depth:</b> 11.0'-12.0' <b>Sample Number:</b> S-4A □ <b>Sample Source:</b> B-GB-13 <b>Depth:</b> 11.0'-12.0' <b>Sample No.:</b> S-4A DOUBLE	<b>Remarks:</b> ○ SEAMS AND LAYERS OF SAND NOTED F.M.=0.63 □ 82.6% DISPERSION FOR THE CLAY PORTION OF THIS SAMPLE.

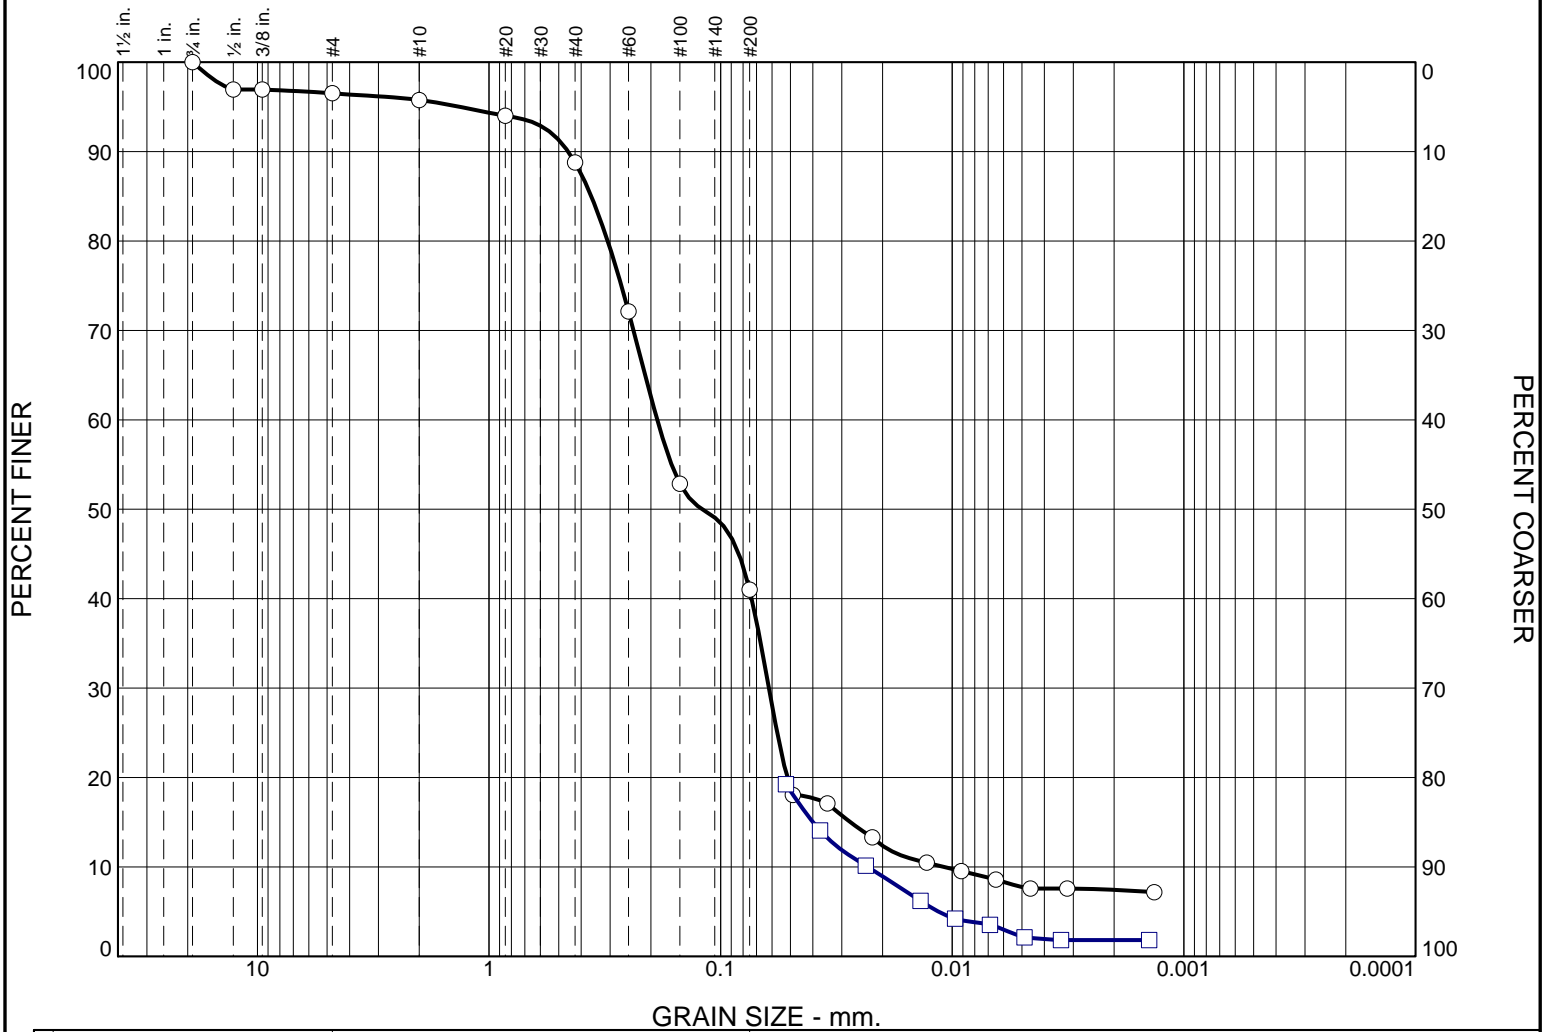
**Remarks:**  
○ F.M.=0.91  
□ 28.2% DISPERSION FOR THE CLAY PORTION OF THIS SAMPLE.
